WEYMOUTH BAY COASTAL DEFENCES

IN PICTURES, PAST & PRESENT

ROCKWATCH FIELD TRIP SERIES

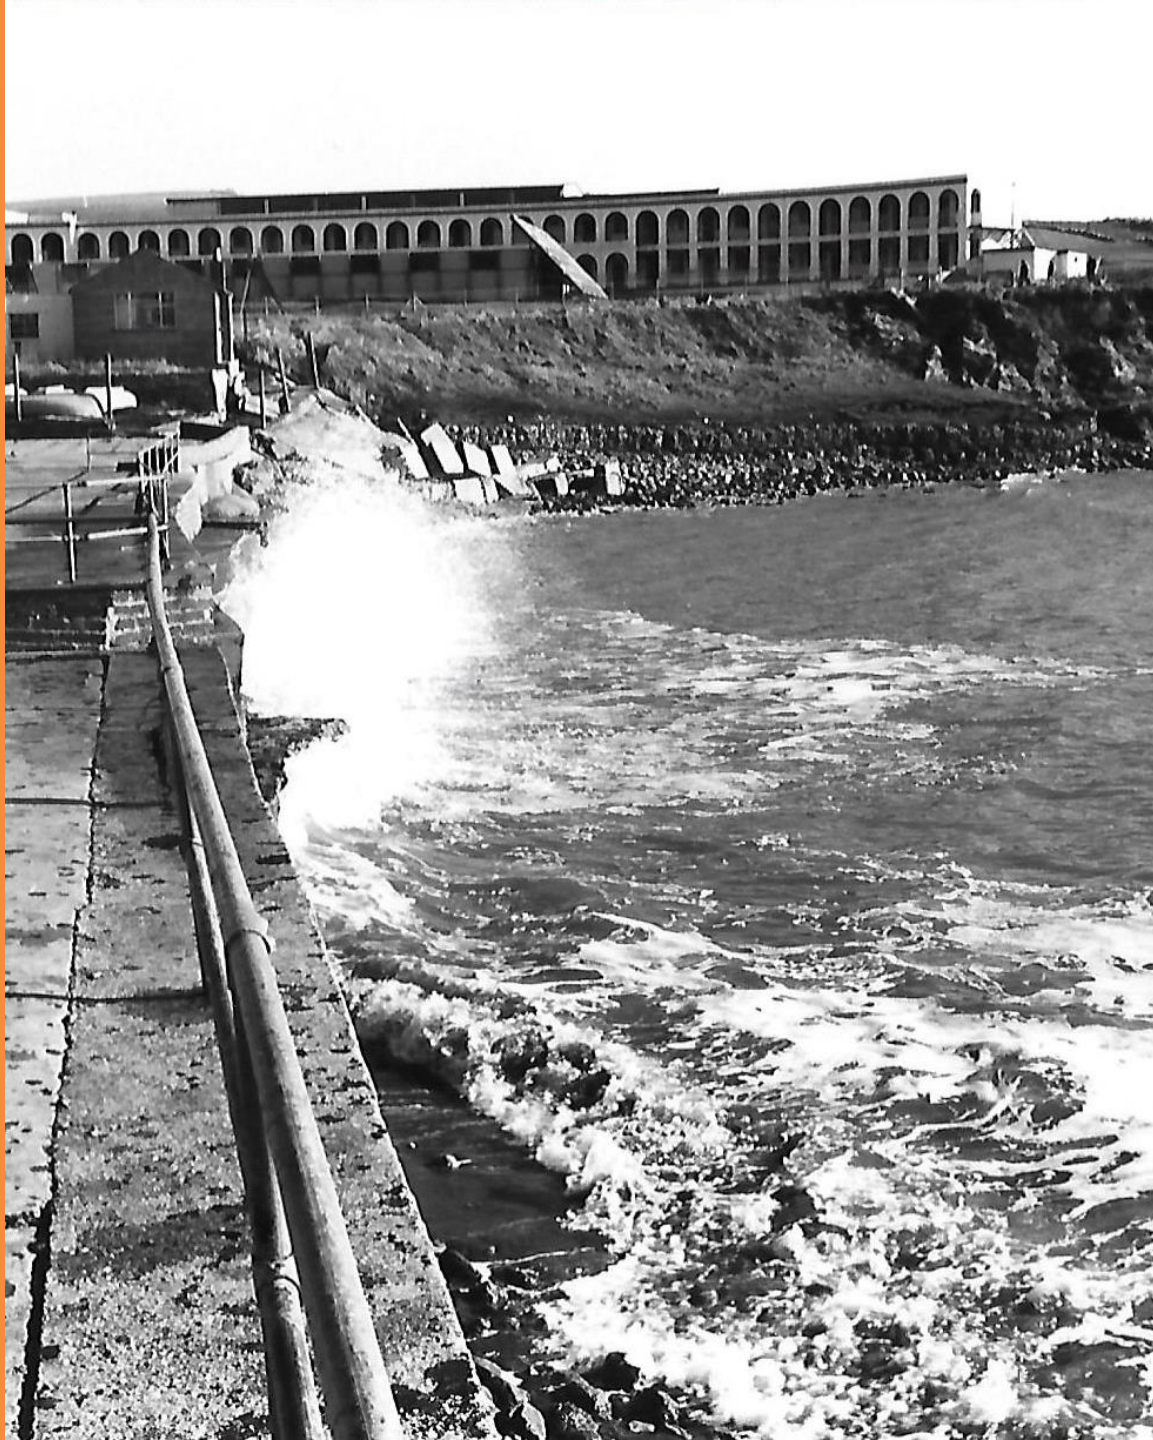
View of Bowleaze Cove, in the autumn of 1978 with gabions at the back of beach and hard engineering.

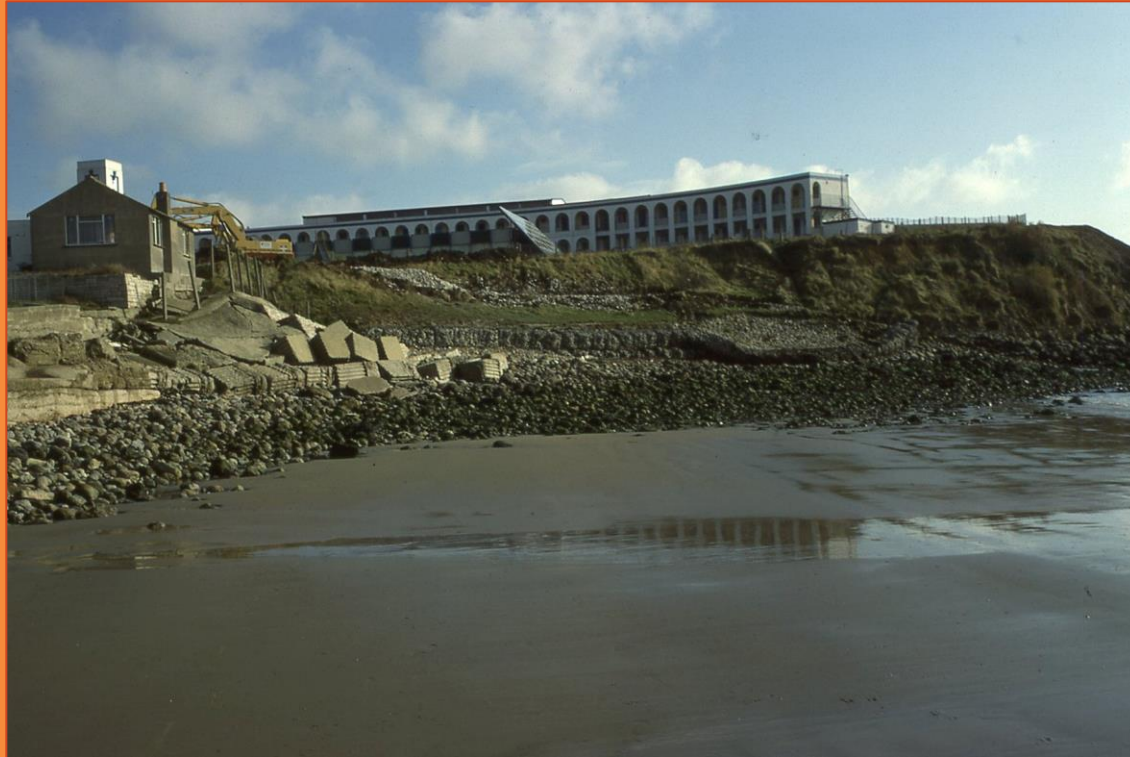
Construction of new defences about the start

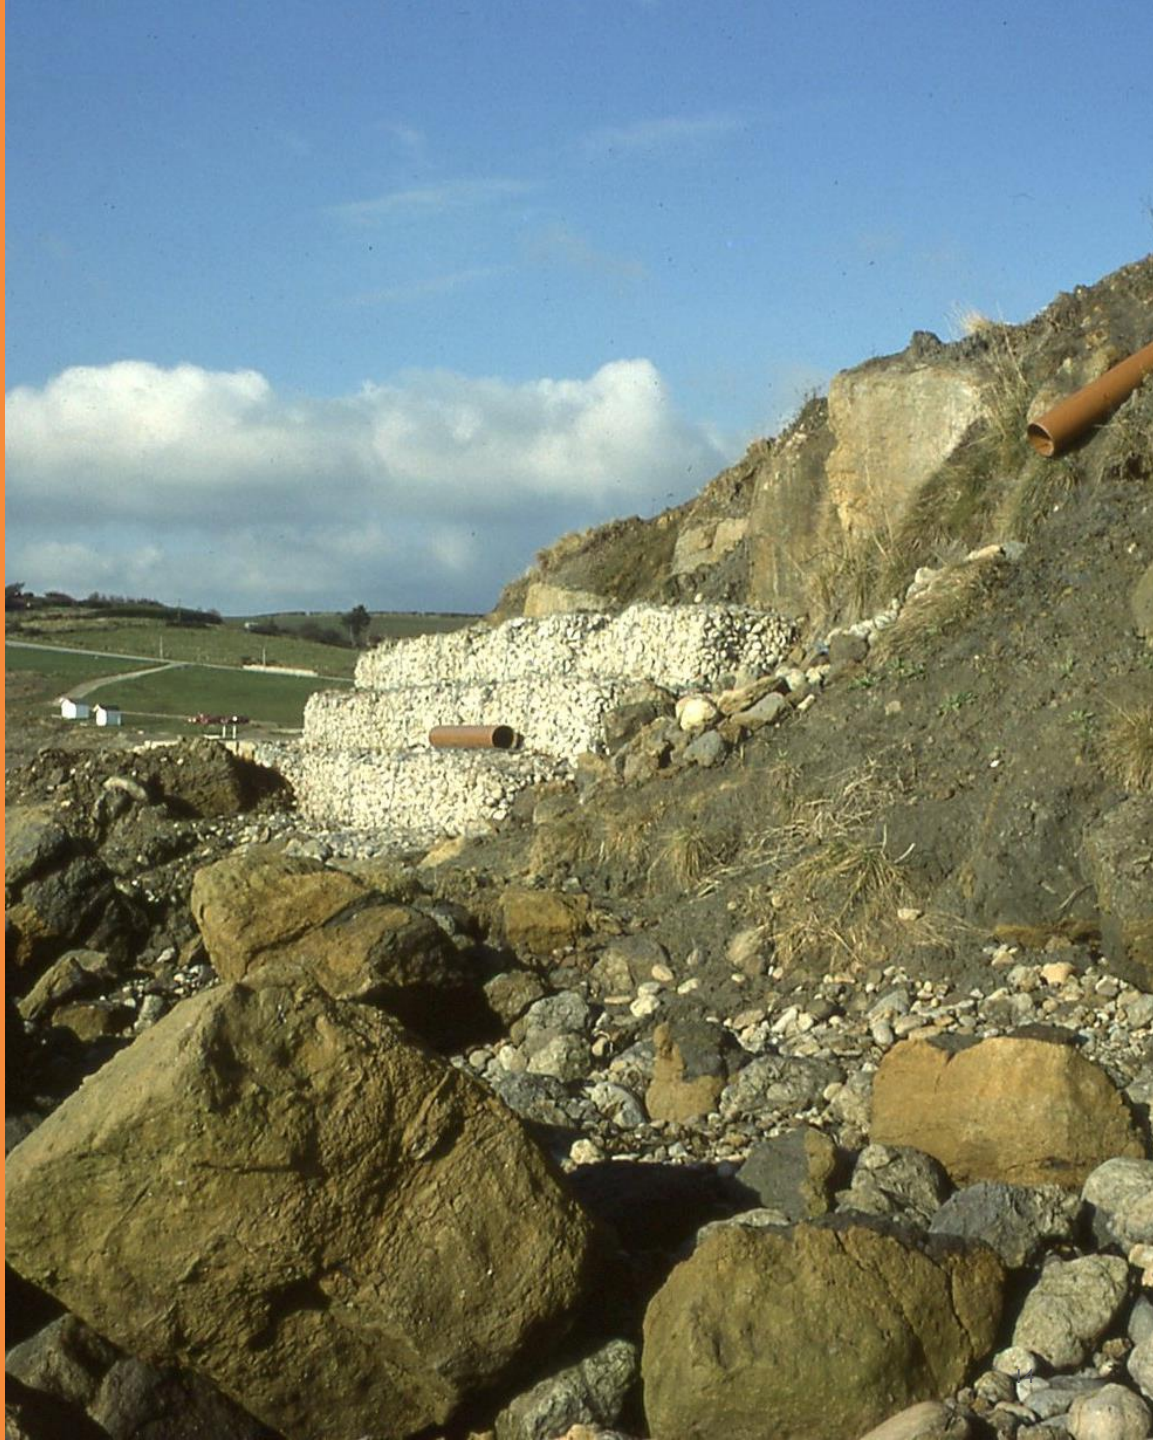
Protection for Riviera Hotel included gabions, drainage and slope grading, costing £60,000.

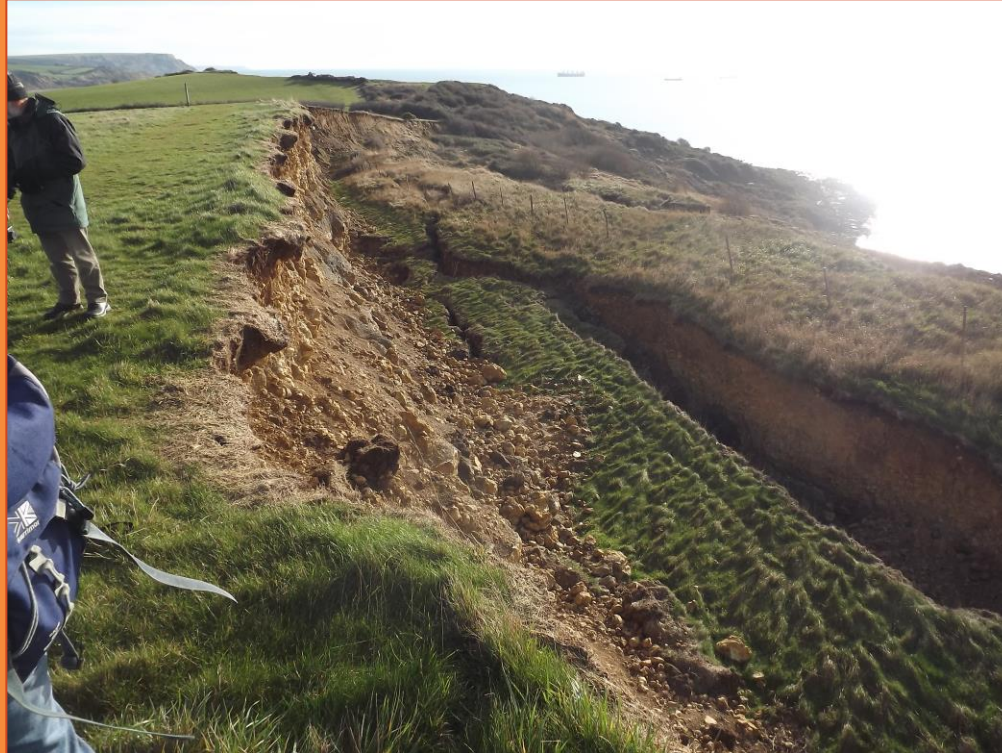
Fence well and truly in the landslip!

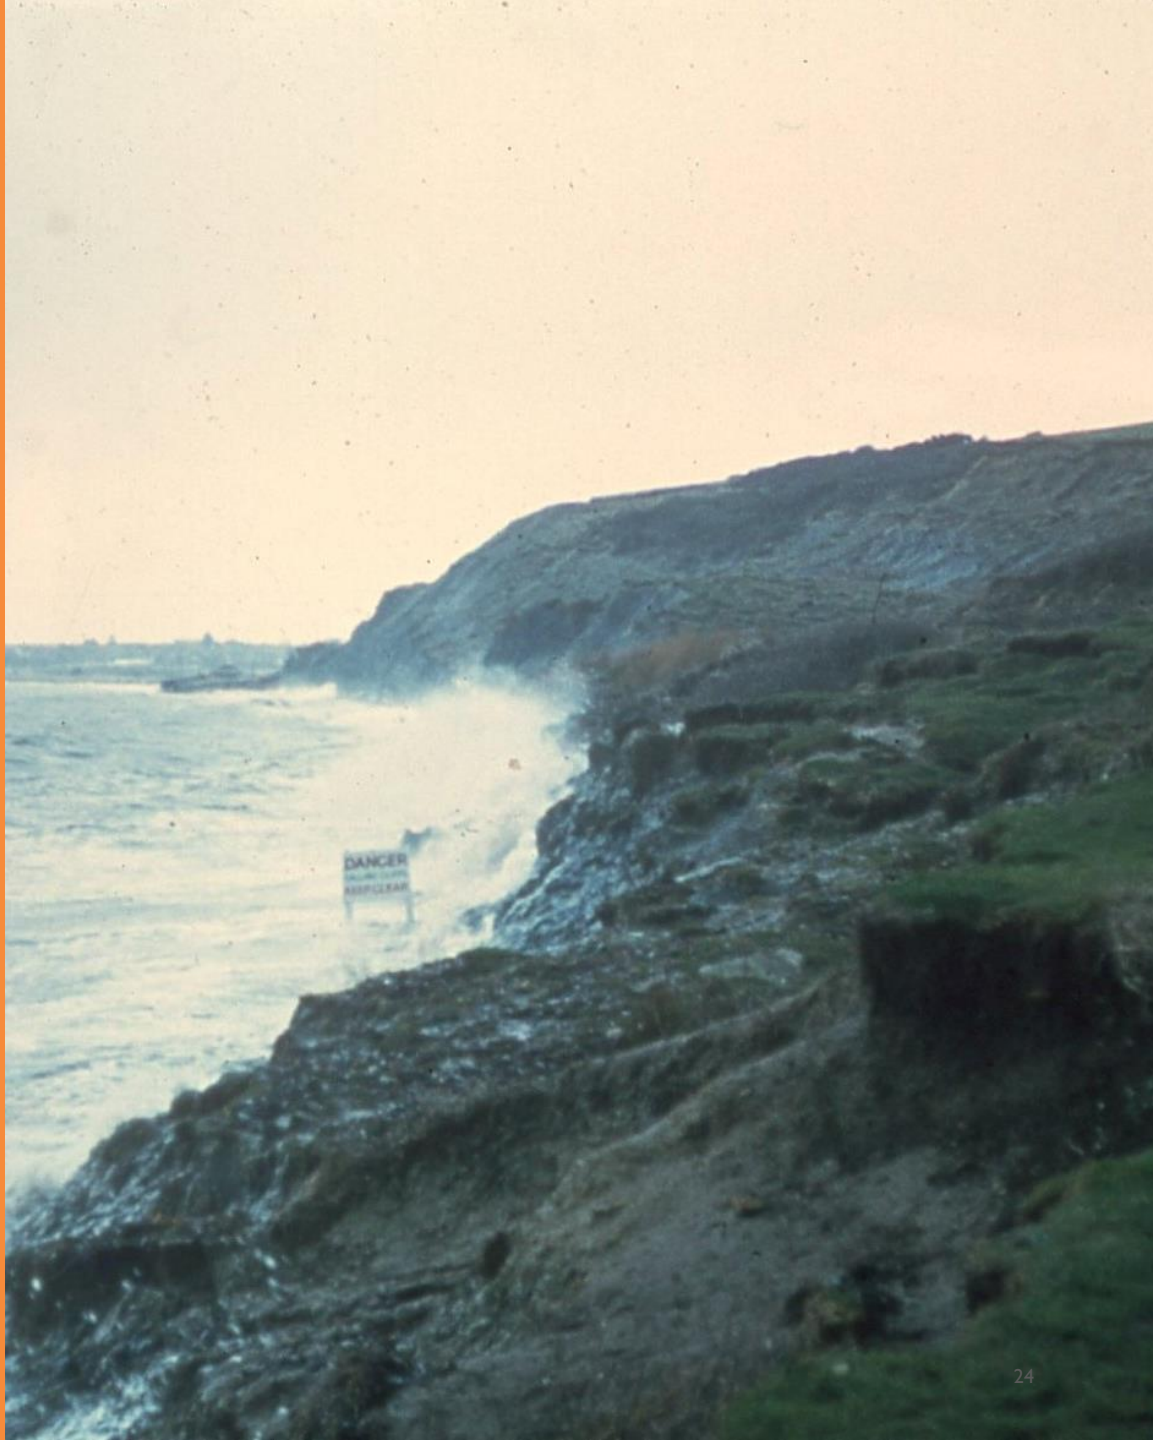
High tide and stormy conditions in the 1970s, leading to serious marine erosion of the Oxford Clay.

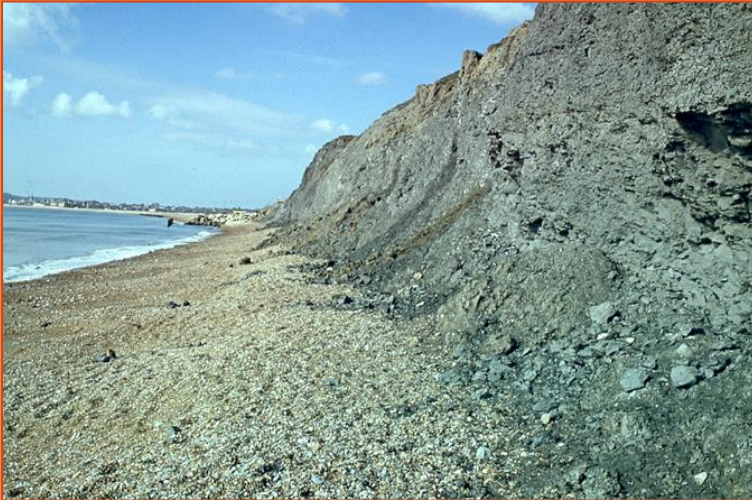
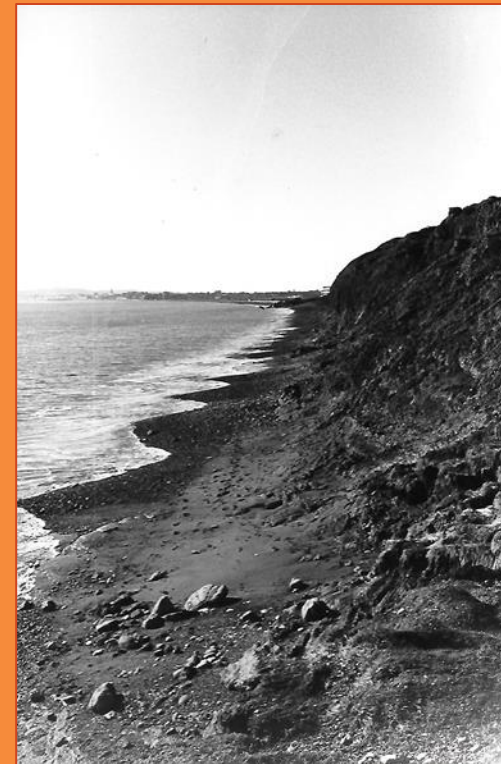
More peaceful conditions in 1978 and the early 1980s. The steep slope of the clay cliff means it was unstable.

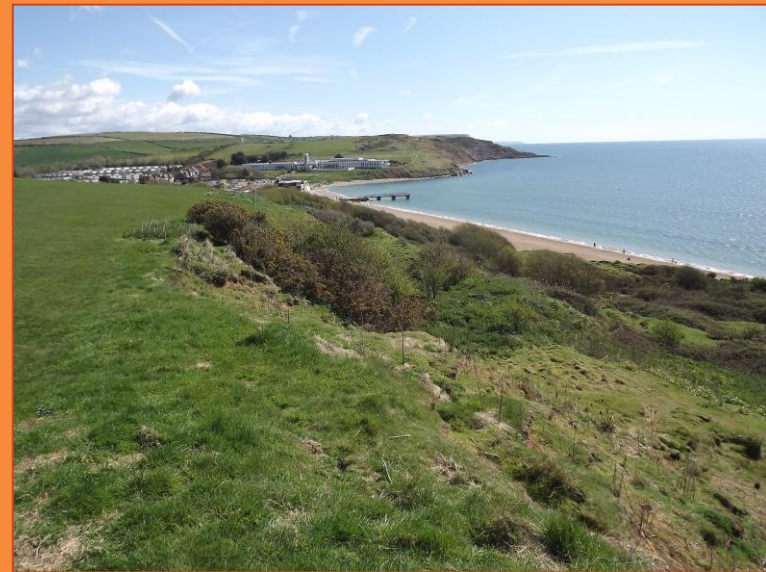
Eastern end of Furzy Cliff in April 2016, showing clear evidence of greater stability with well established vegetation.

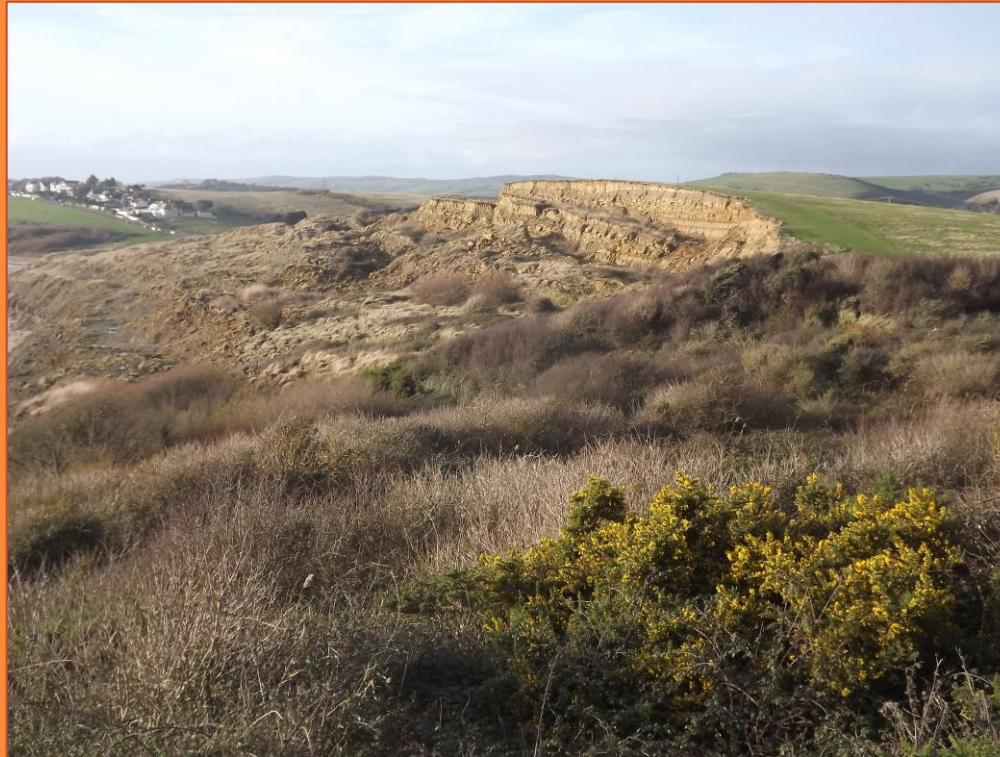
View of Redcliff from Redcliff Point looking North West, showing the problem with no protection. This is an excellent example of rotational slip mass-movement

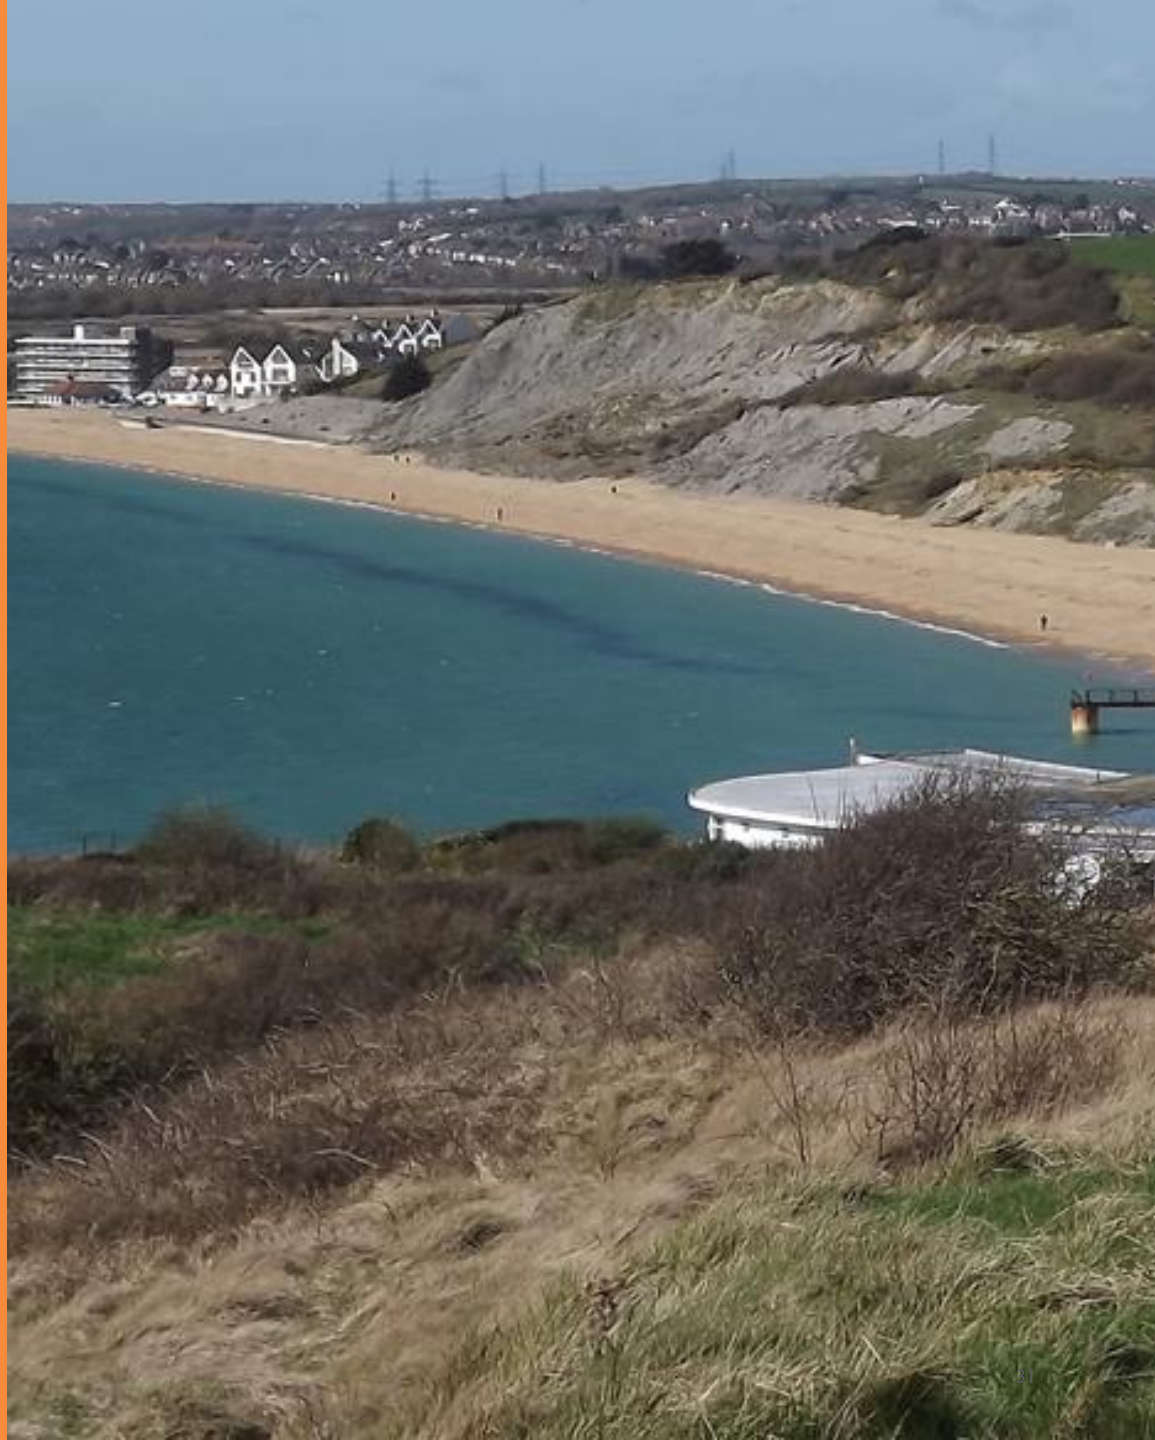
VICTORIAN DEFENCES

Off shore evidence of rock armour from late Victorian times attempts to limit erosion.

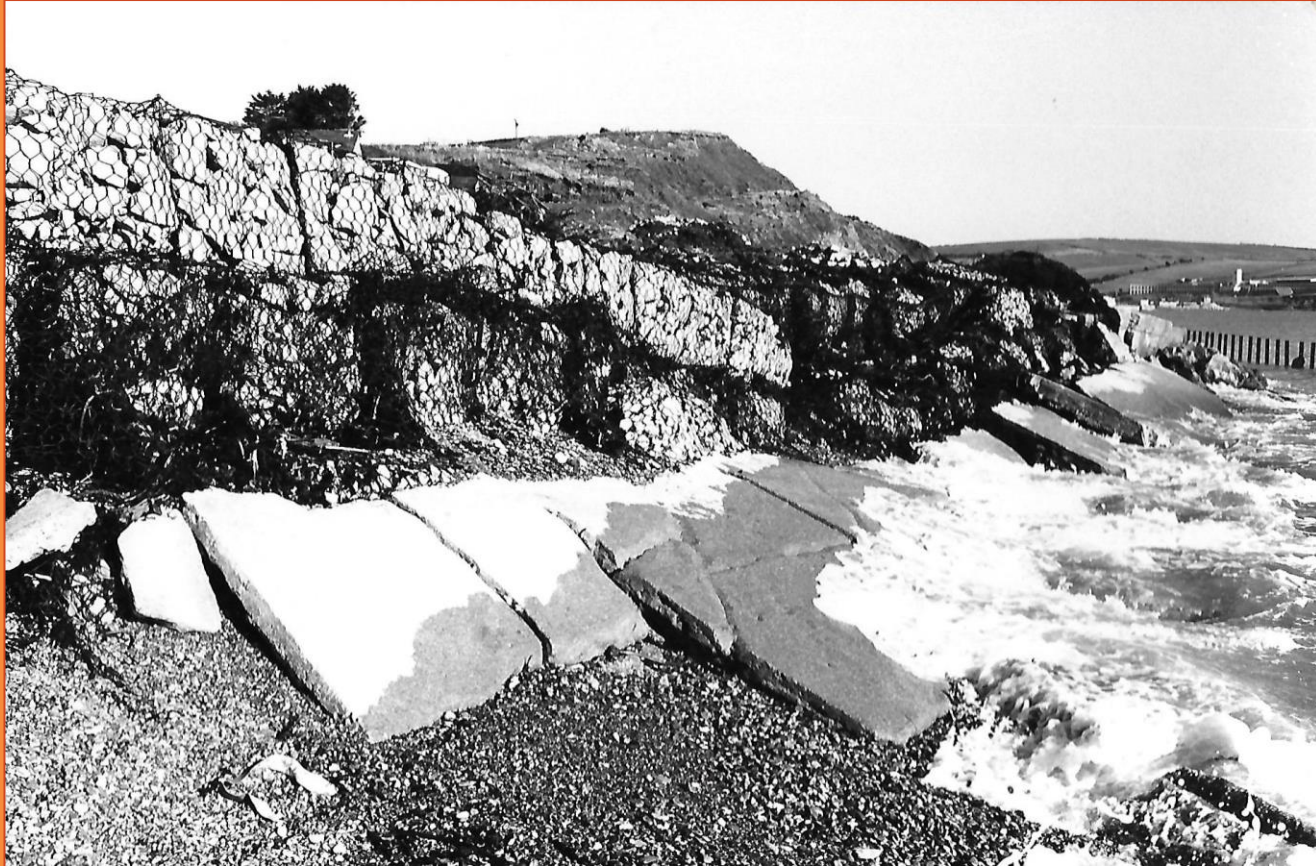
Closer view of the defences, date of construction unknown.

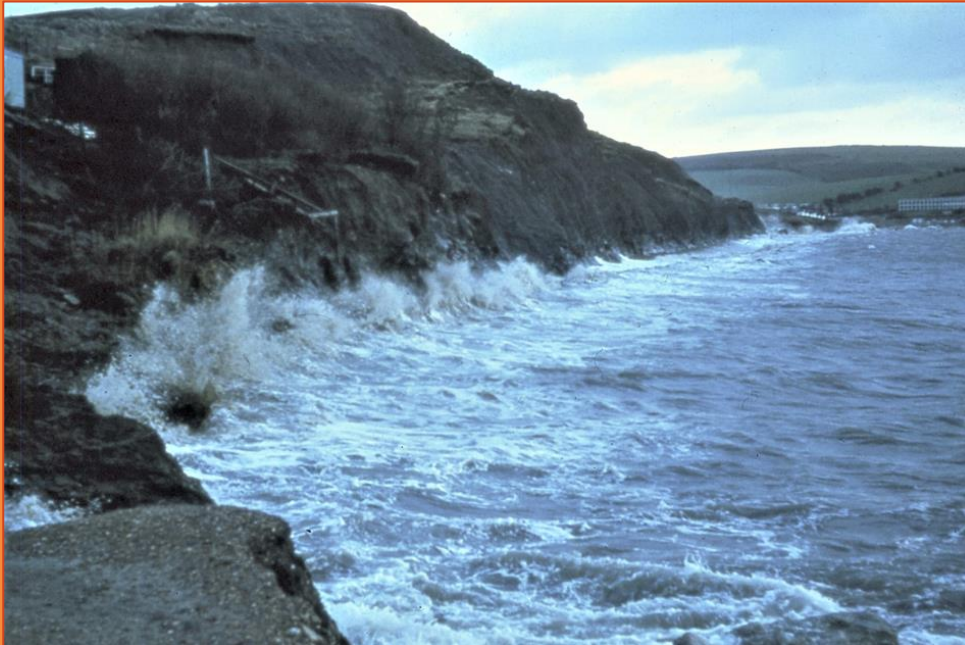
High tide at Overcombe resulting in further erosion particularly of the Oxford Clay.

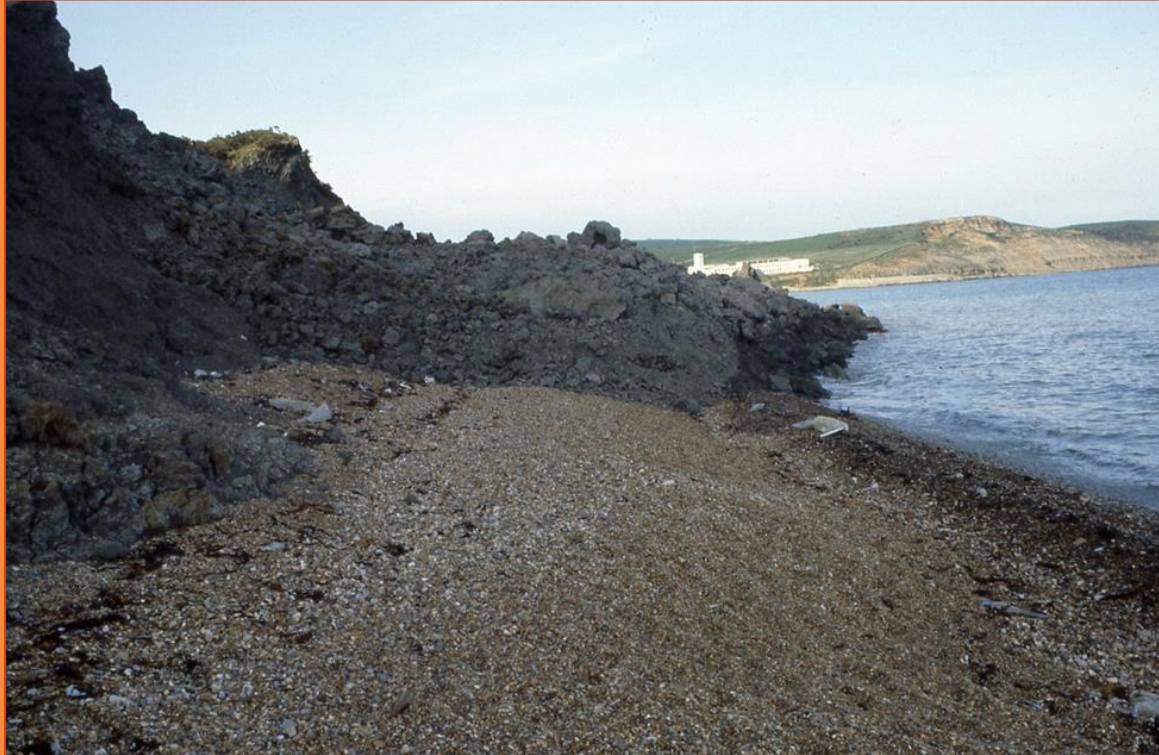
Oxford Clay slumping across the beach

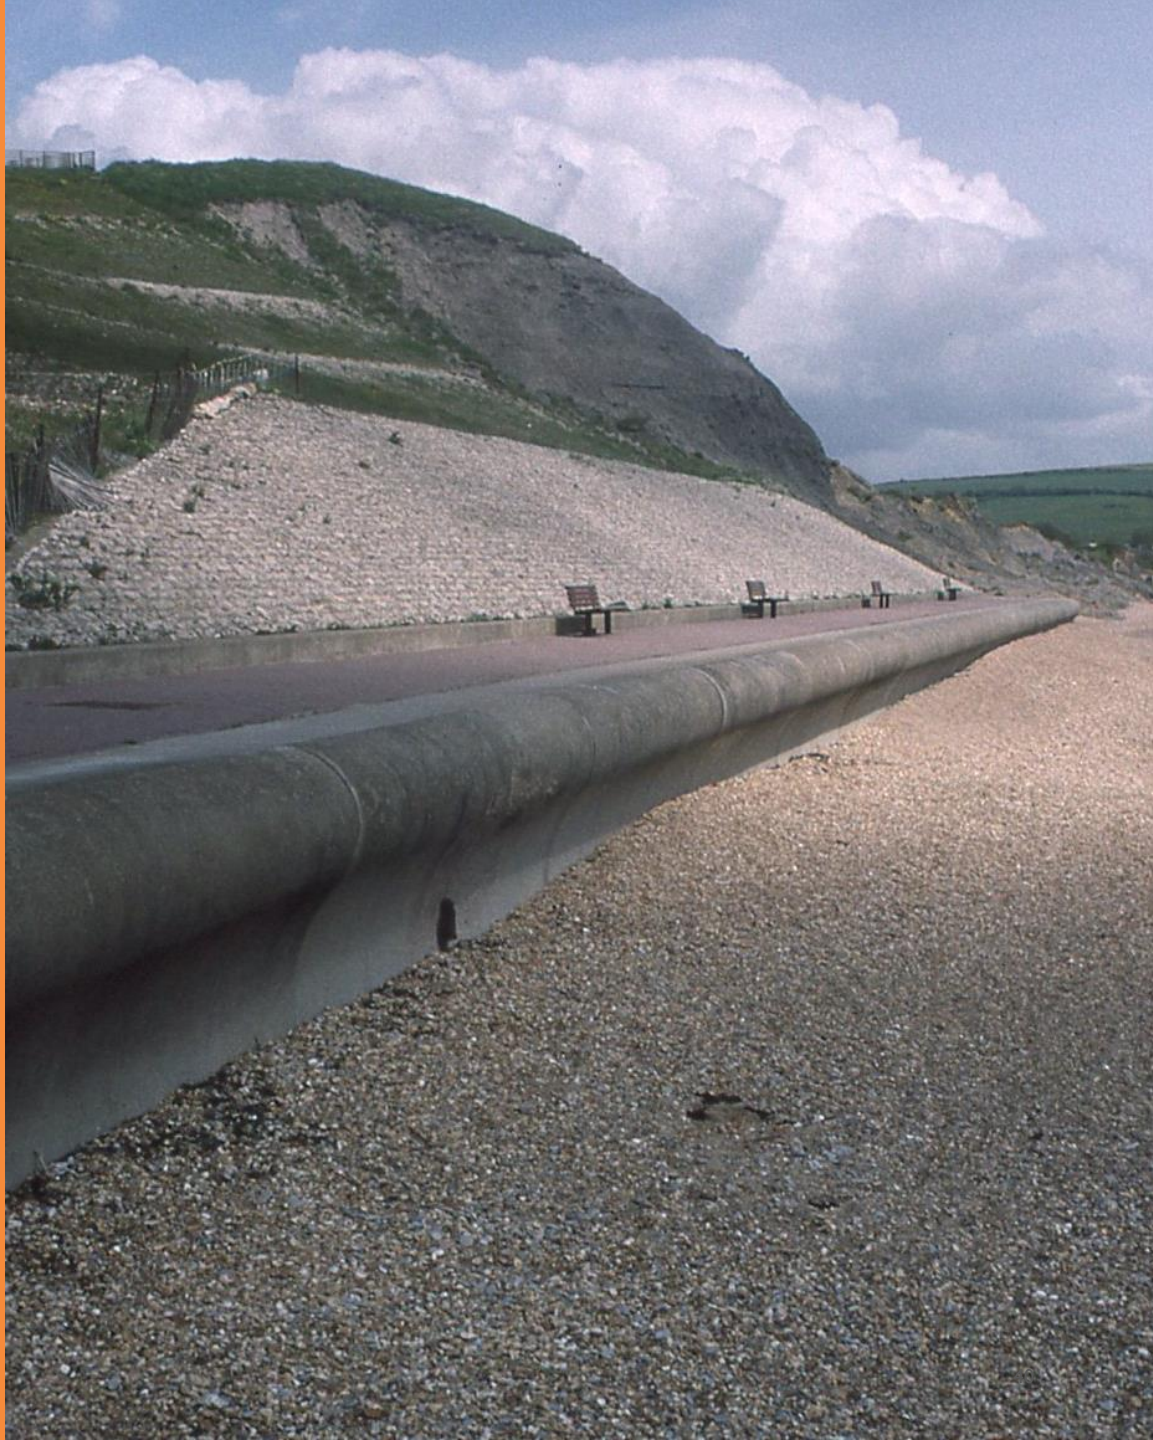
View taken in 1996 following Preston Beach Road Scheme beach replenishment. Furzy Cliff now protected from marine erosion except in extreme circumstances.

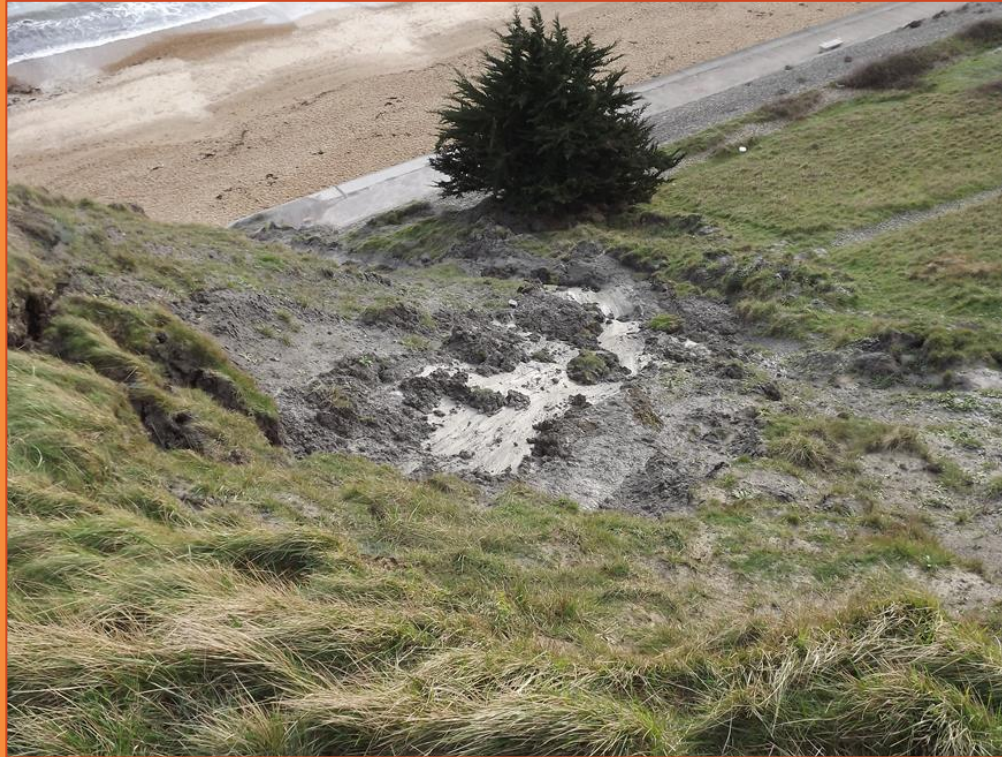
1983-4 defences cost c. £400,000.
This view was taken in 1996.

The beach had been built up due
to the beach replenishment
scheme along Preston Beach
Road.

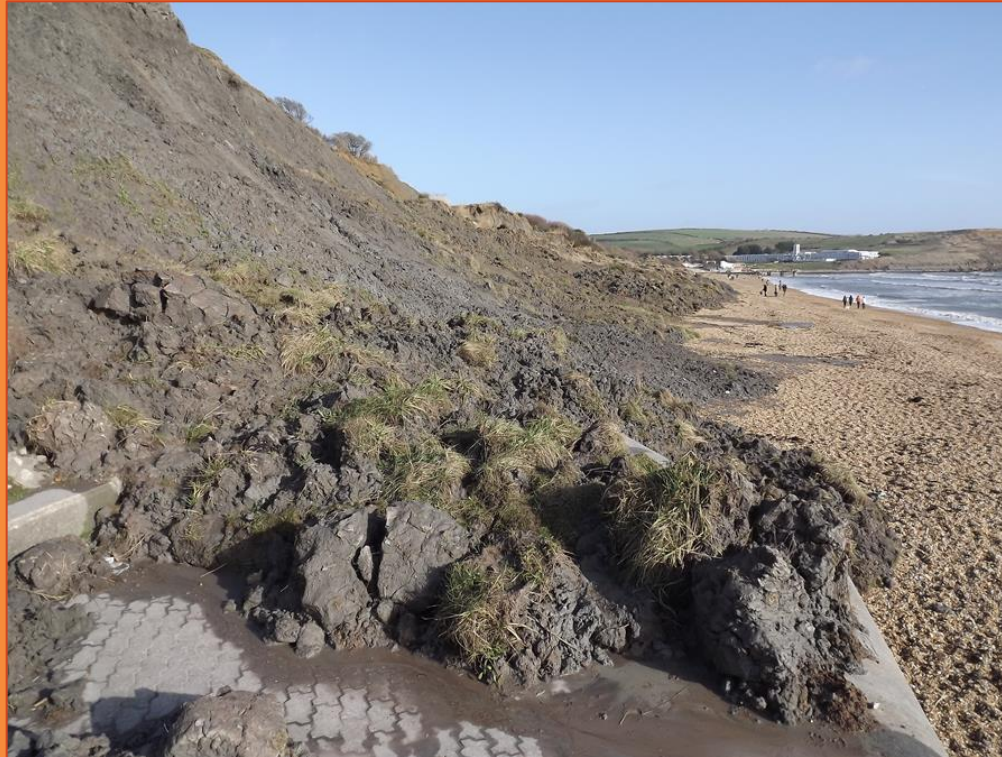
View in 2013 showing slumping still occurs after wet weather but it is not as severe as it was.

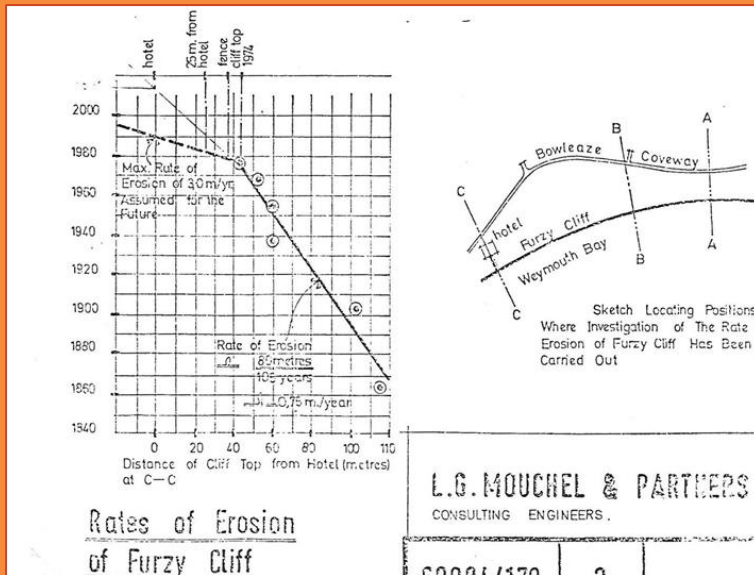
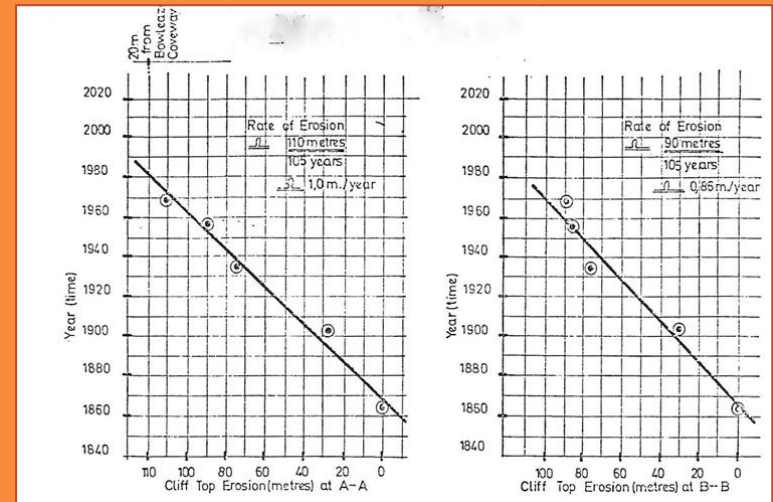
PROJECTED EROSION RATES ALONG FURZY CLIFF DURING PREPARATION FOR OVERCOMBE CORNER PROTECTION 1983-4

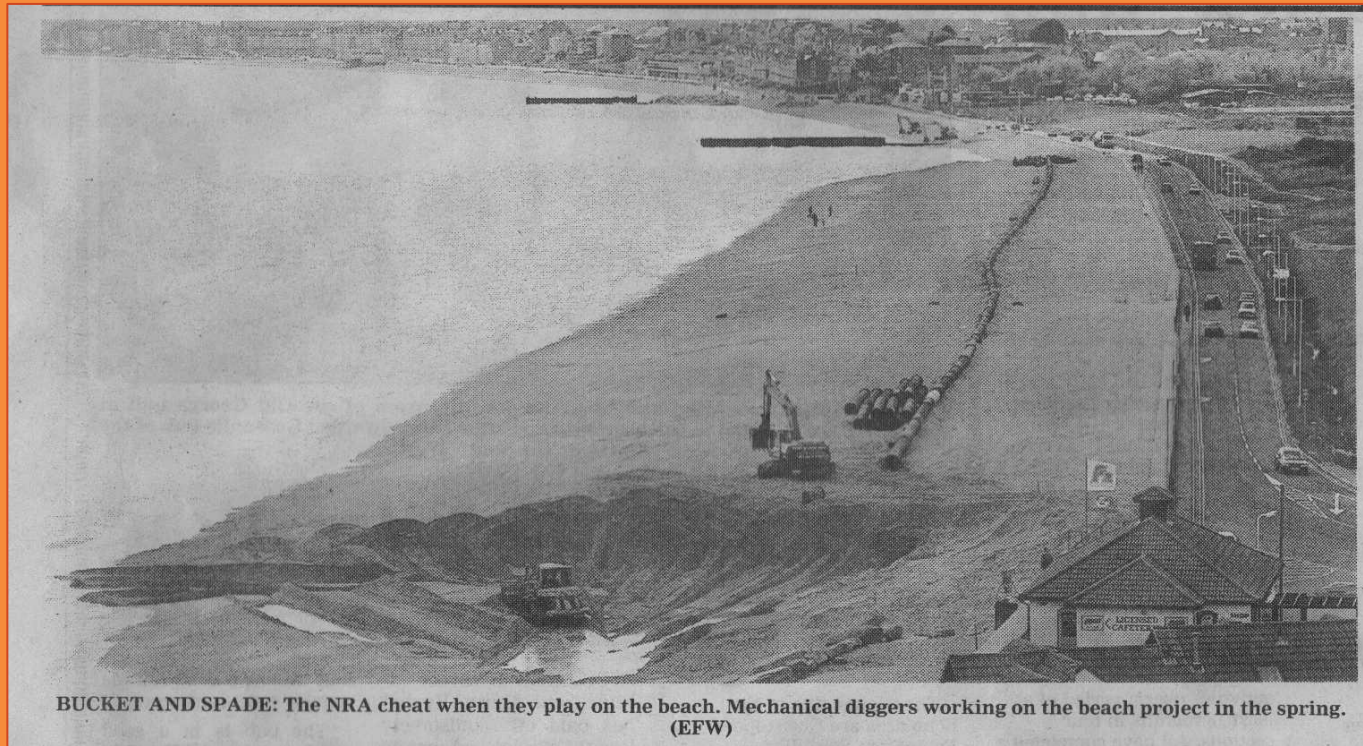
Beach replenishment work in 1995.

214,000 cubic metres of shingle from the Needles borrow area off the Isle of Wight.

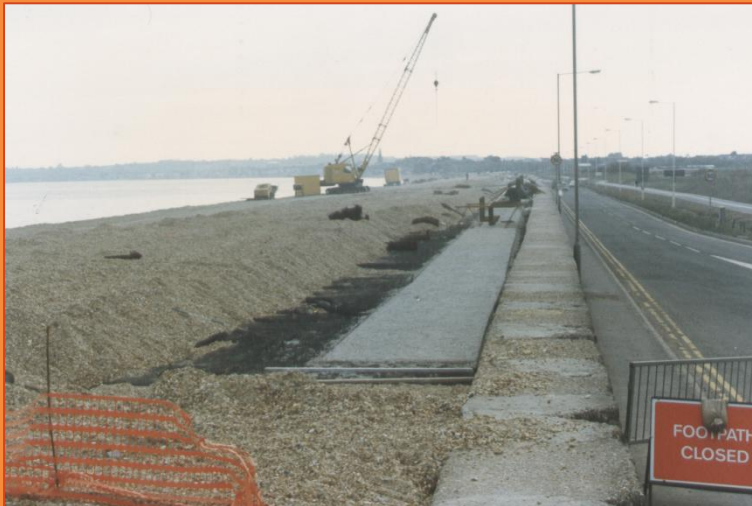
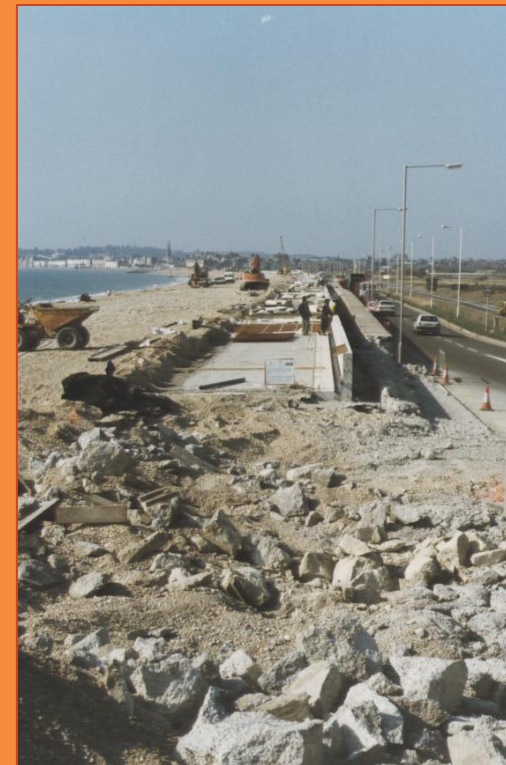
NEW SEA WALL BEING BUILT, COST AROUND £6 MILLION

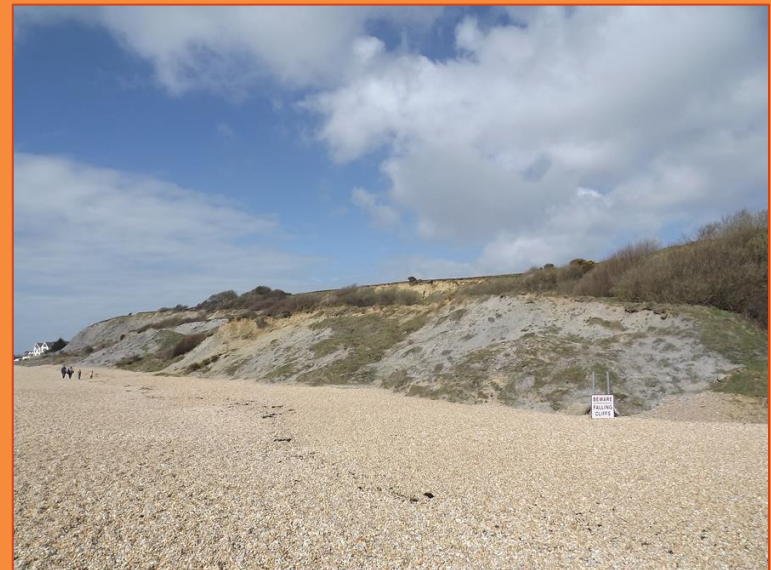
Things changed in 2016. Beach replenishment at Preston Beach Road has now provided protection for the cliff so marine erosion is unlikely and subaerial slumping has created a more stable slope.

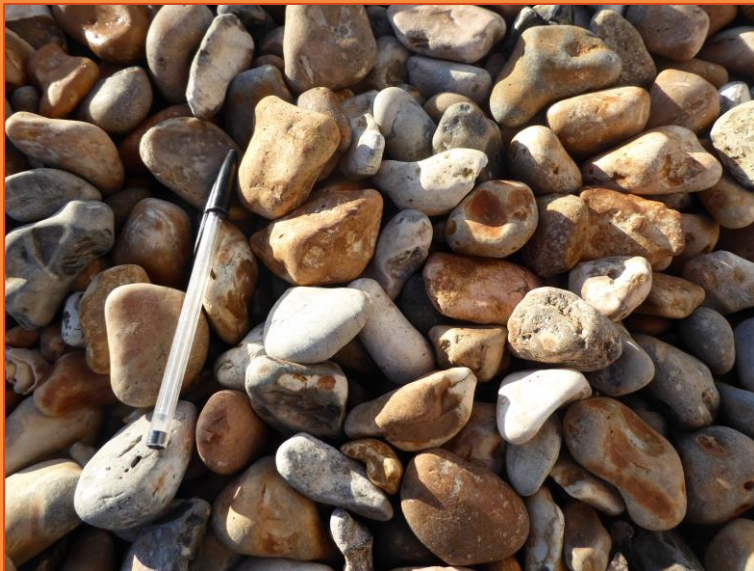
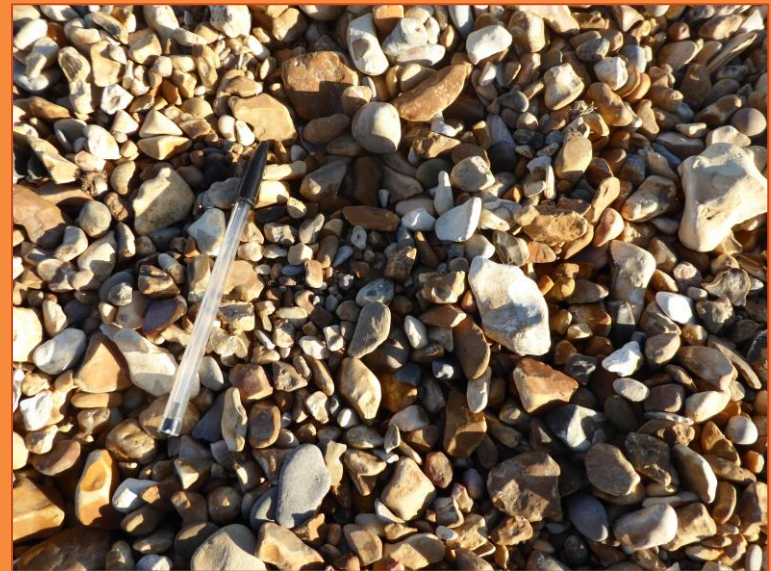
THE WRONG KIND OF SHINGLE AT GREENHILL, RIGHT, AND THE RIGHT KIND AT PRESTON BEACH ROAD, LEFT

The shingle from the beach replenishment scheme for Preston Beach Road now protects Furzy Cliff from marine erosion and the steepness of the slope of the cliff is slowing reducing so it becomes more stable. It is not as well rounded as beach shingle which affects its porosity and permeability.

It is not as well sorted as beach shingle hence after the beach was being eroded it was sieved to remove the sand. Sorting is to do with grain size. Well sorted shingle is all the same size, poorly sorted shingle is all different sizes. When waves break on a beach like Chesil Beach the water can pass between the pebbles rather than washing it away.

The shingle from off the Isle of Wight was deposited by a river when sea level was lower during a glacial period. This was less well sorted than beach shingle and was eroded by wave action.

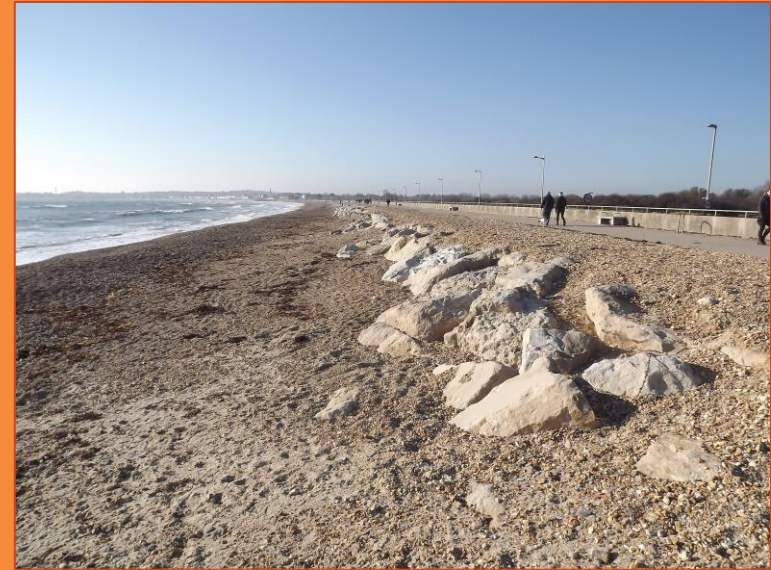
Rock armour put in place in 2014

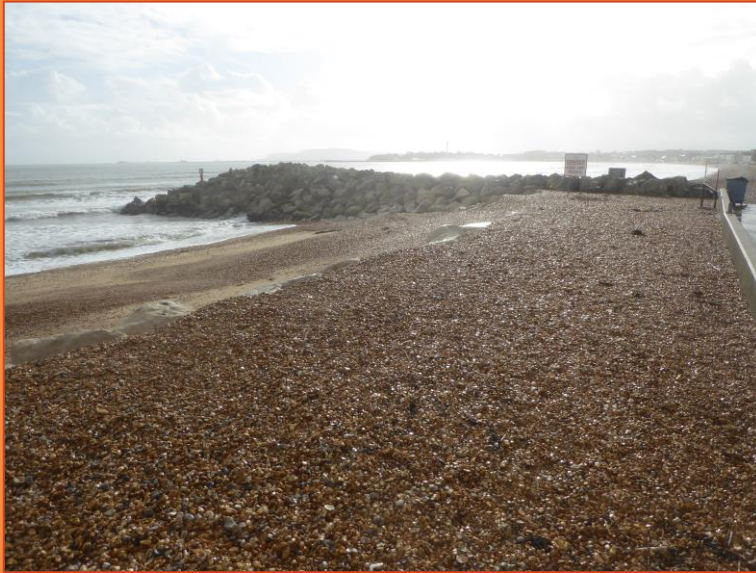
The groyne at Greenhill designed to stop shingle moving towards Weymouth. Why didn't they put a groyne at Overcombe?

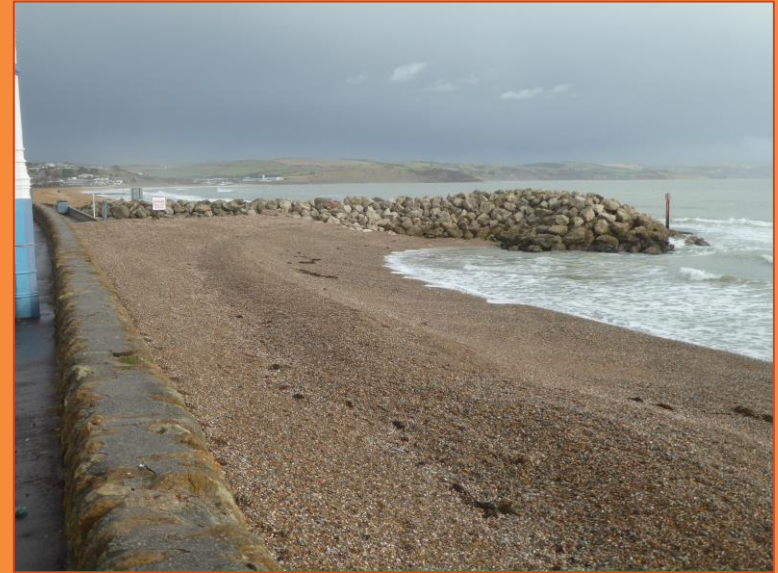
6,200 tons of Portland Stone
