COASTAL PROTECTION AT SWANAGE

ROCKWATCH FIELD TRIP SERIES
ALAN HOLIDAY

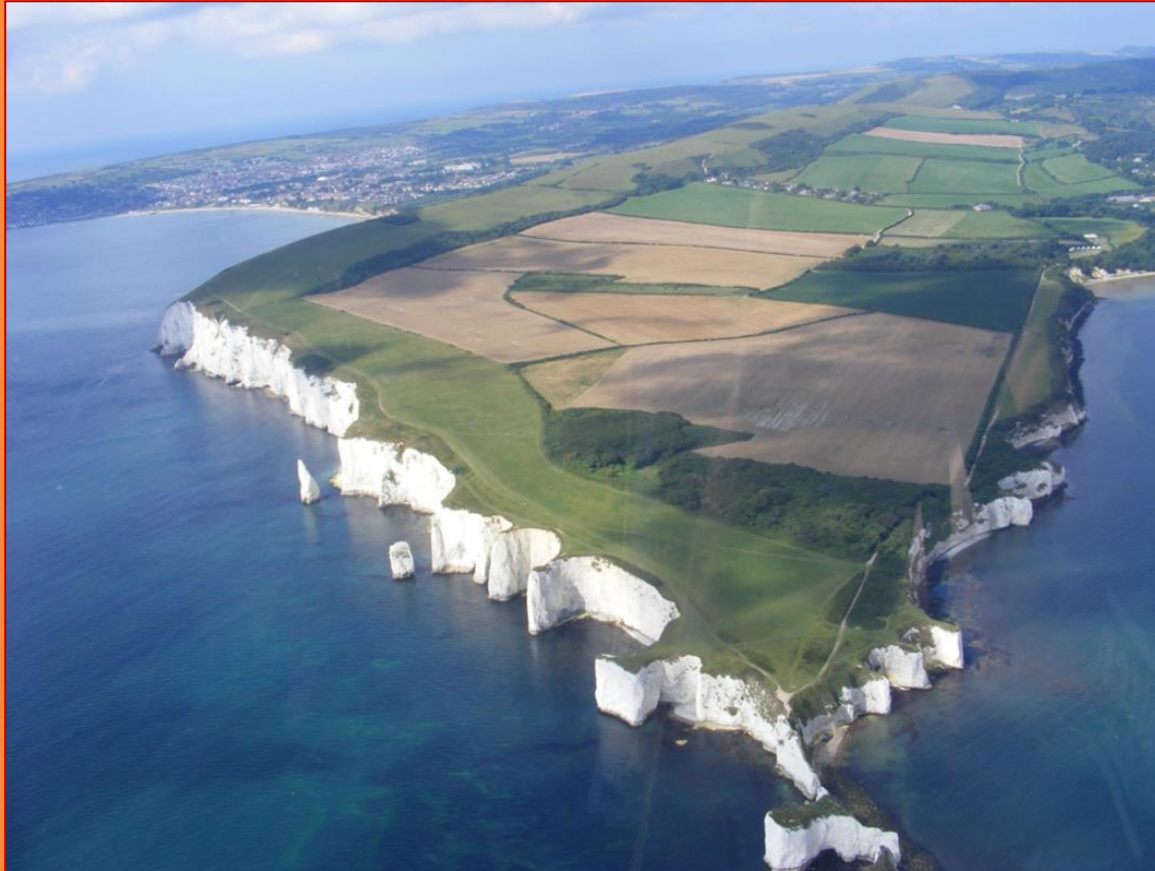
AERIAL VIEW OF BALLARD DOWN FROM THE NORTH EAST

The Chalk is relatively harder so forming a headland with the Old Harry Rocks in the foreground.

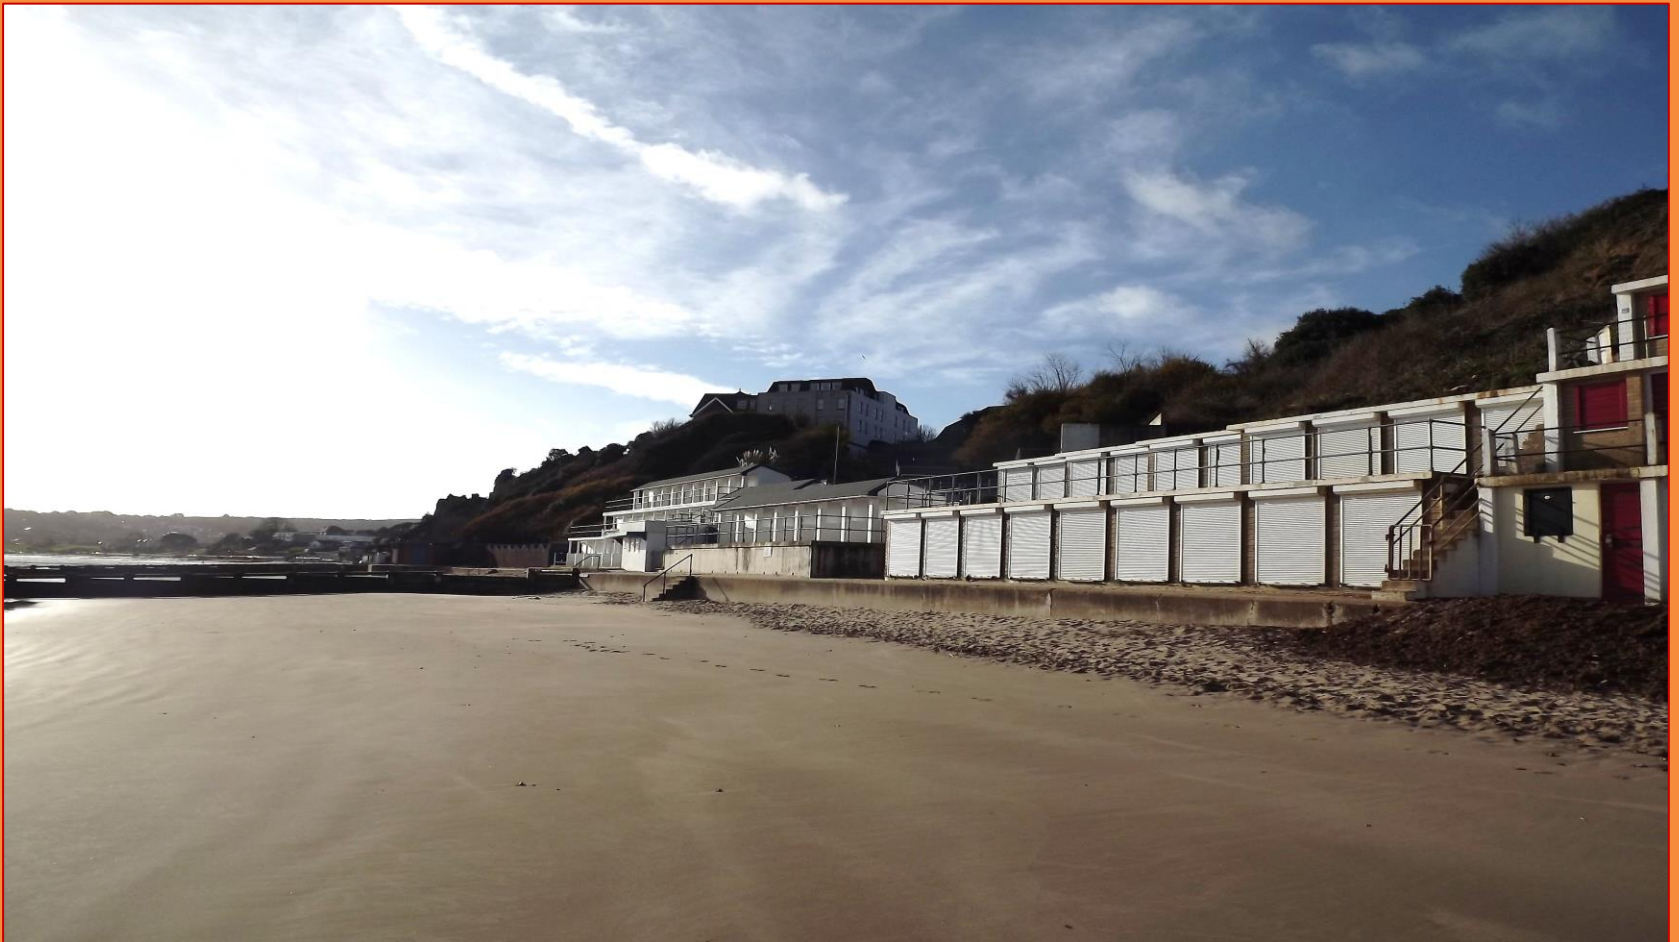
IN SWANAGE BAY A SEA WALL PROTECTS THE TOWN

This is an example of 'hold the line' in terms of coastal protection, when property has great value.

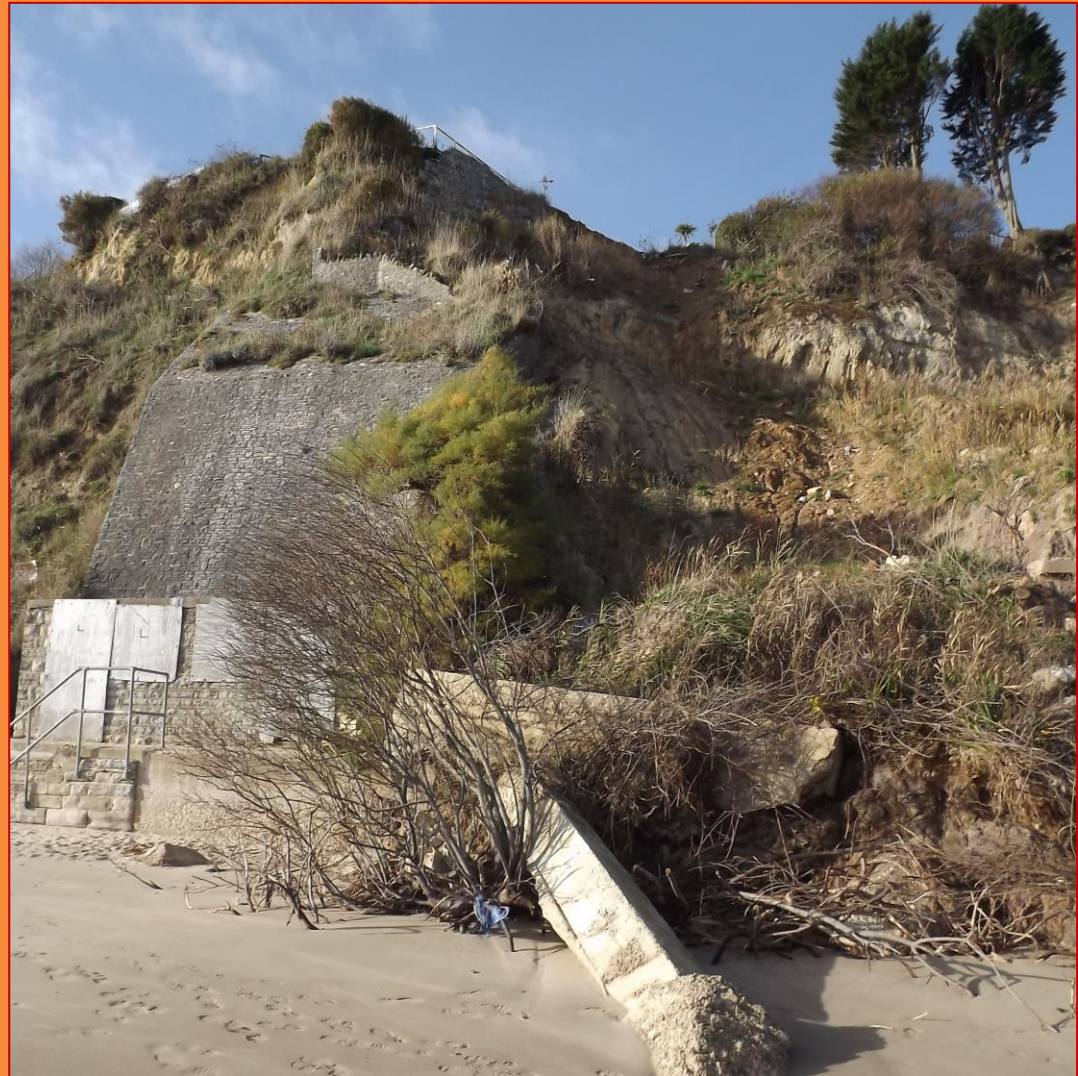
FURTHER NORTH THERE ARE MORE PROBLEMS

Here the cliff face is higher and the weak Wealden Bed, consisting of sandstone and clay are more liable to be affected by landslides. You can see remains of earlier attempts to protect the cliffs.

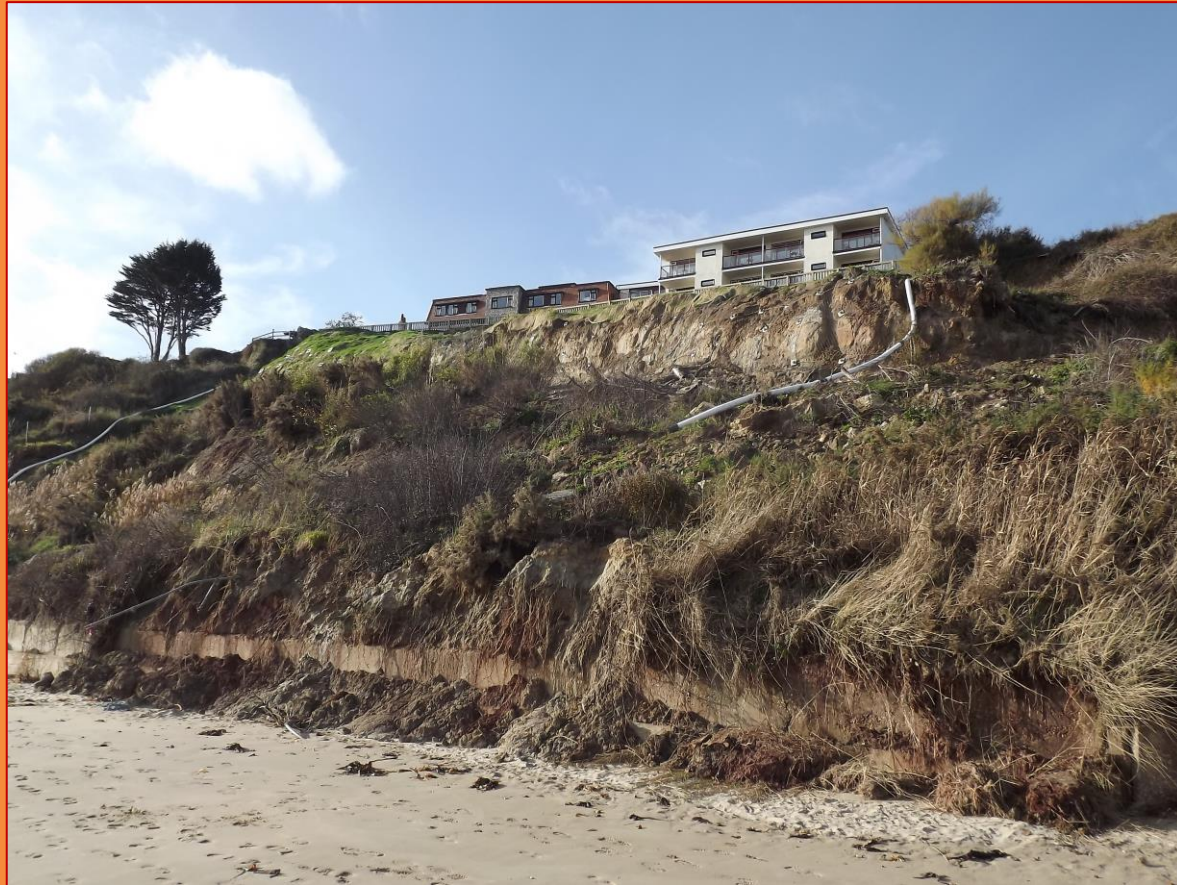
THE PINES HOTEL LANDSLIDE

This picture was taken in December 2013 following a major landslide below the Pines Hotel.

The pipes are there to drain the ground because water makes landslides more likely.

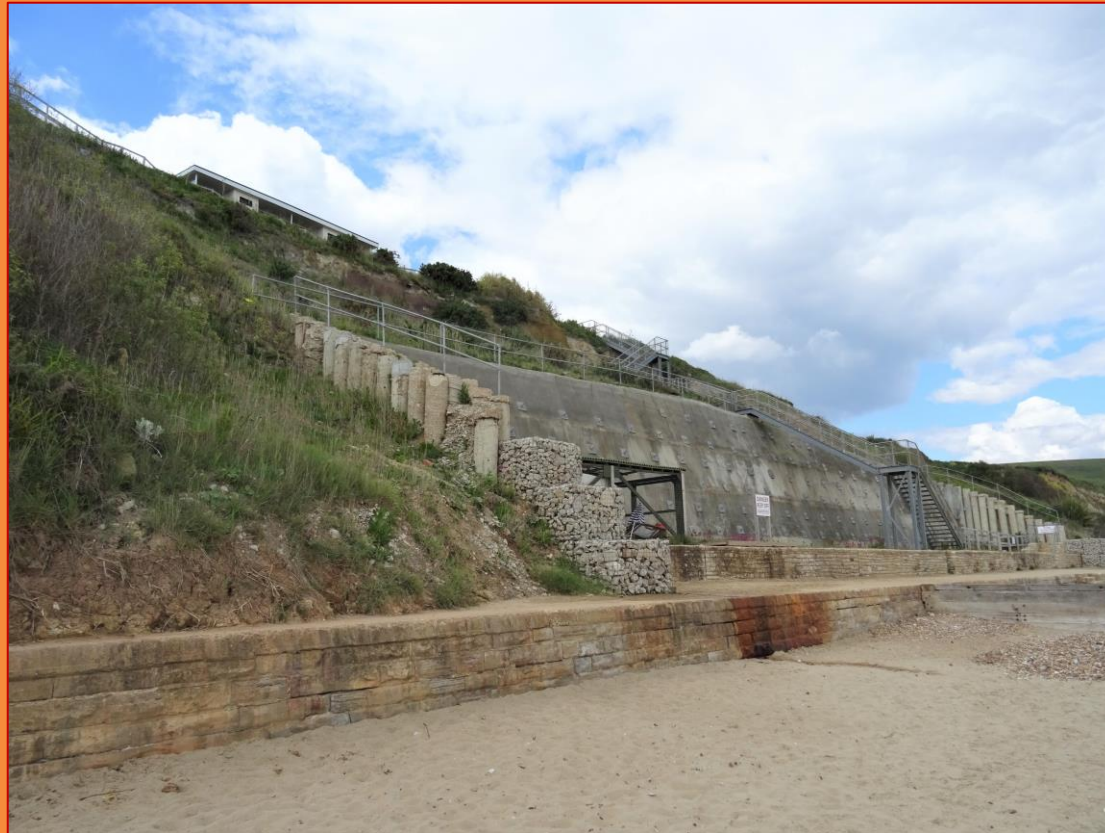
OVER A MILLION POUNDS HAS BEEN SPENT PROTECTING THE PINES HOTEL

This involved drainage, building a supporting wall, rock bolts and soil nails to hold the cliff together.

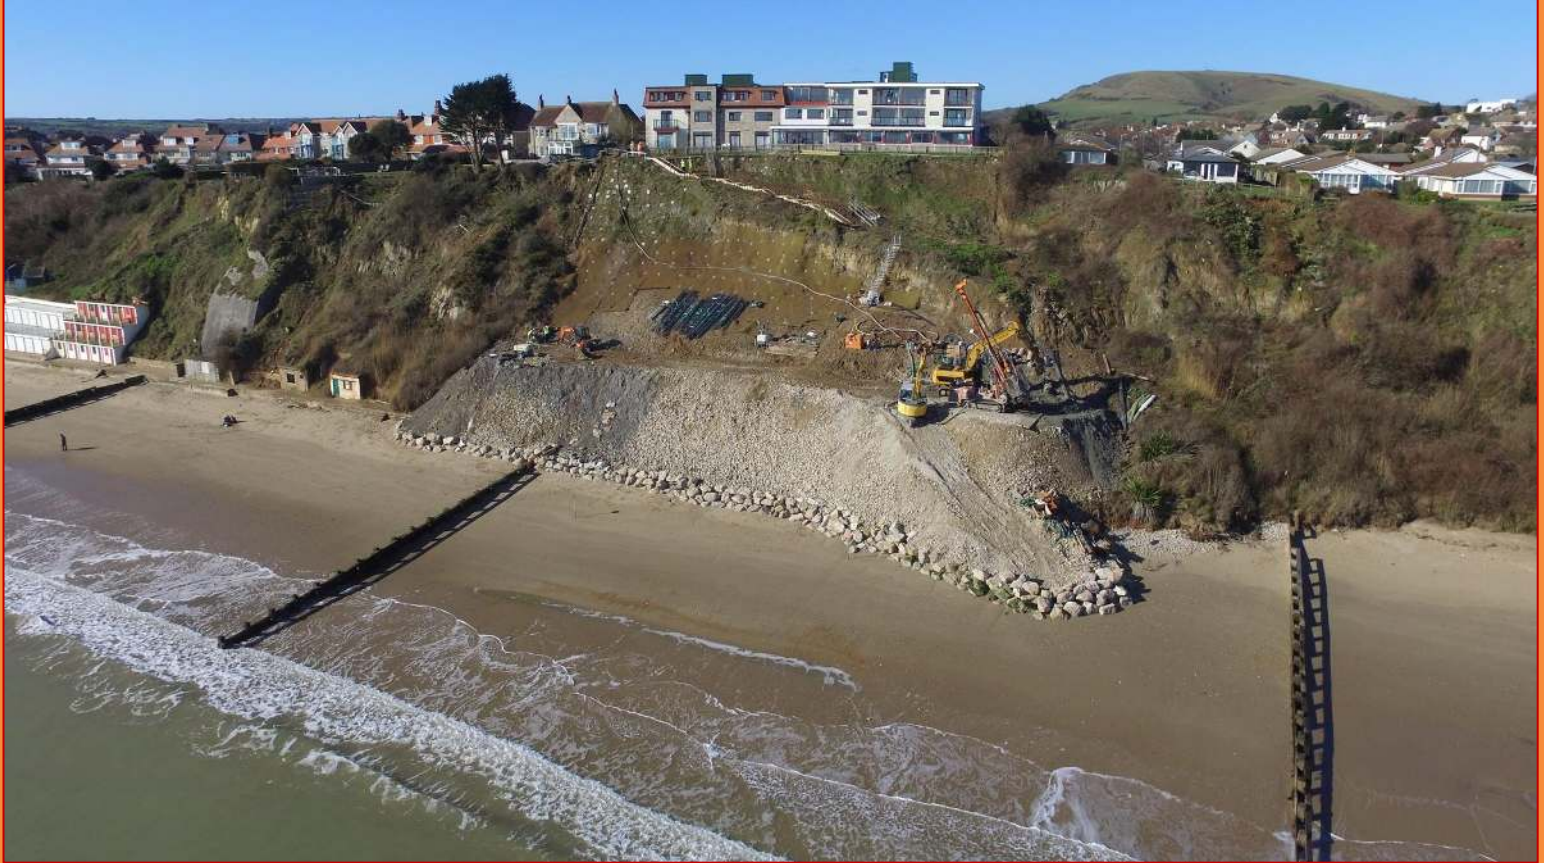
This picture was taken during the construction work to protect the hotel in February 2016.

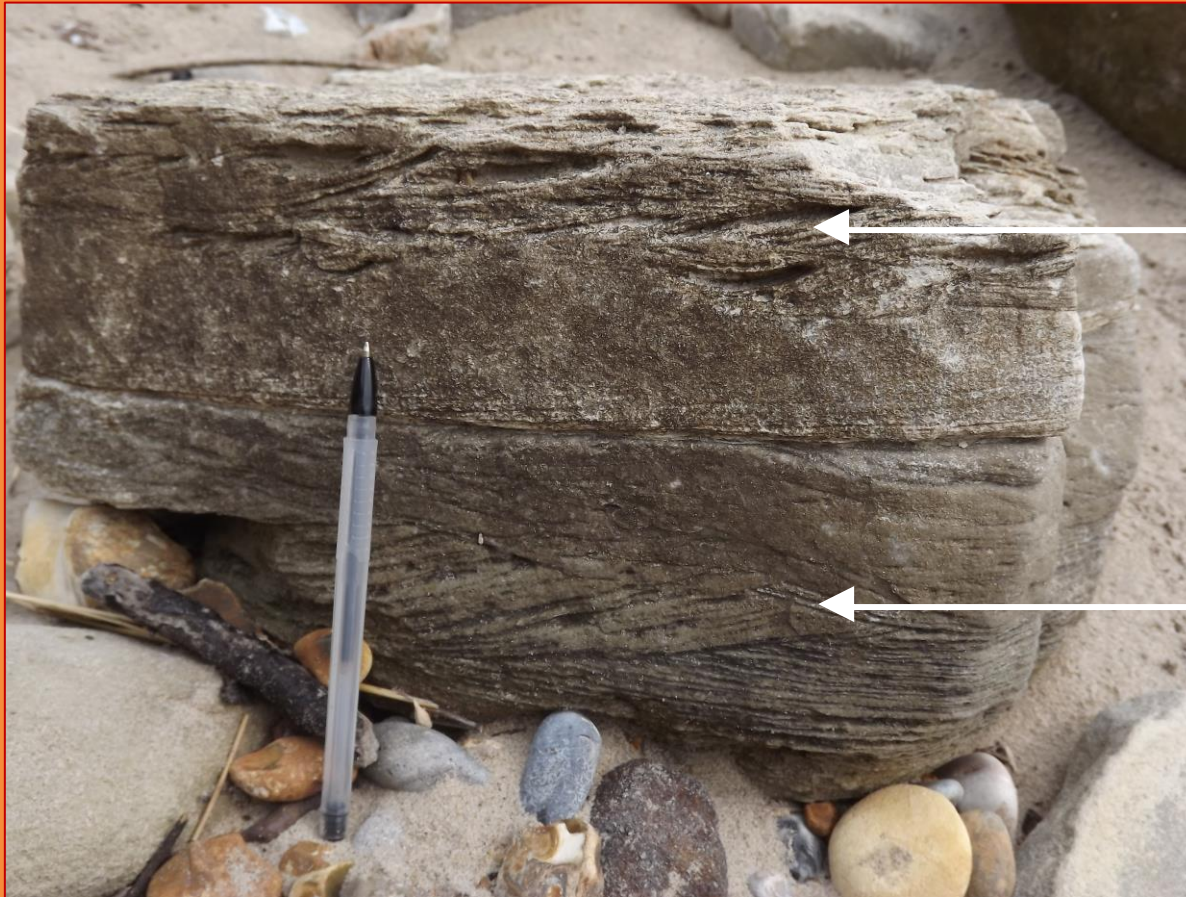
GEOLOGY IS STILL VISIBLE

Evidence of cross-bedding with ripple structures formed on the river bed.

Cross-bedding, due to changes in direction of flow and partial erosion of earlier set by later event.
