# **COASTAL PROTECTION AT SWANAGE**

**ROCKWATCH FIELD TRIP SERIES  
ALAN HOLIDAY**

# BACKGROUND GEOLOGY

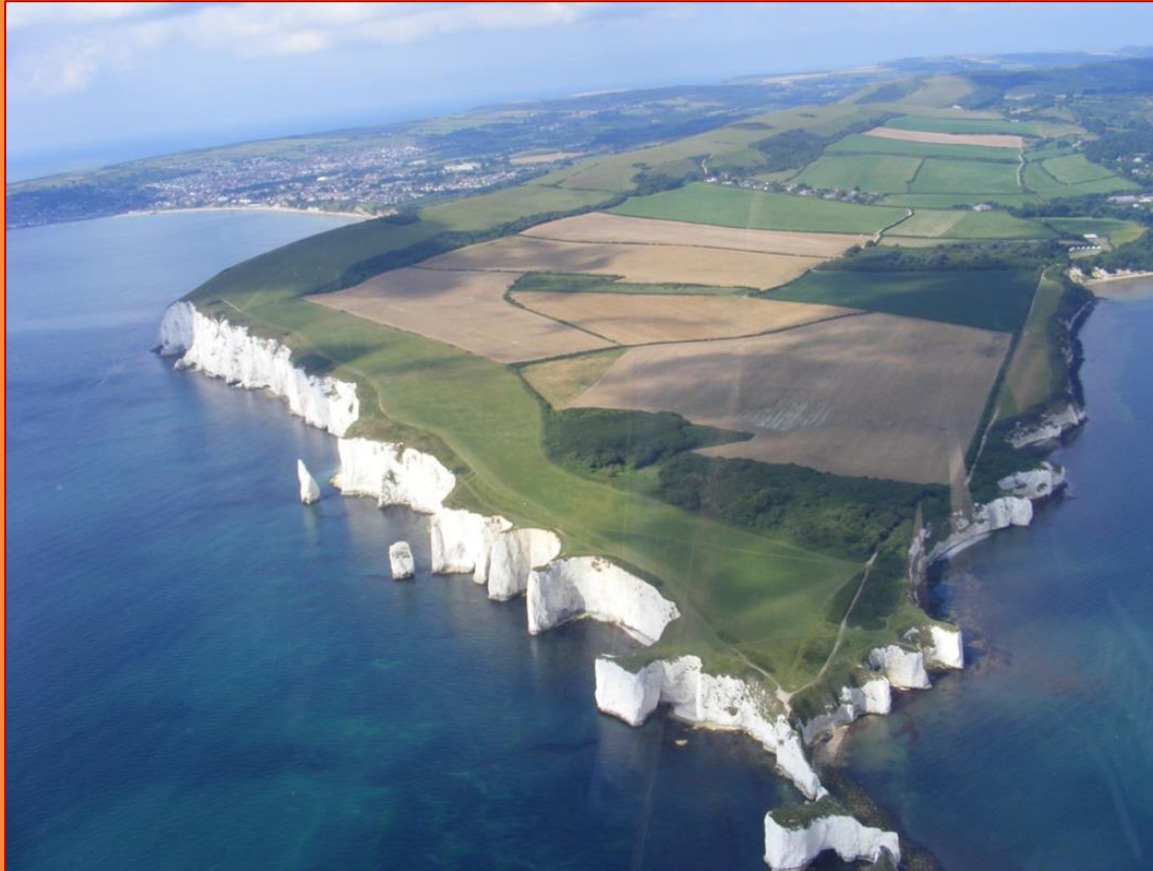
# AERIAL VIEW OF BALLARD DOWN FROM THE NORTH EAST

The Chalk is relatively harder so forming a headland with the Old Harry Rocks in the foreground.

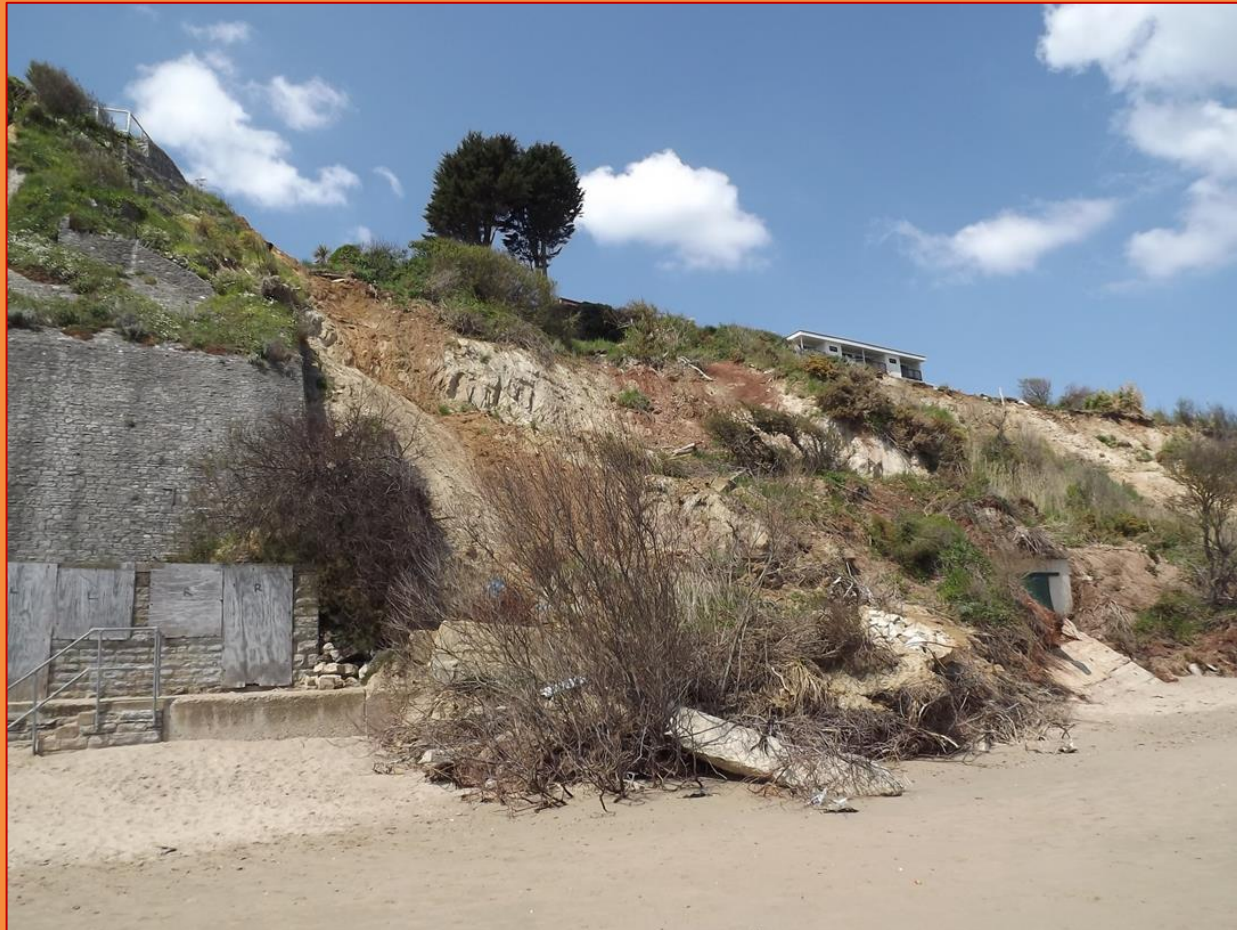
# LANDSLIDE IN SWANAGE BAY IN 2013

The landslide occurred due to wet winter conditions and specifically due to the geology, gravity and presence of water. The sea was not the cause due to the presence of a sea wall.

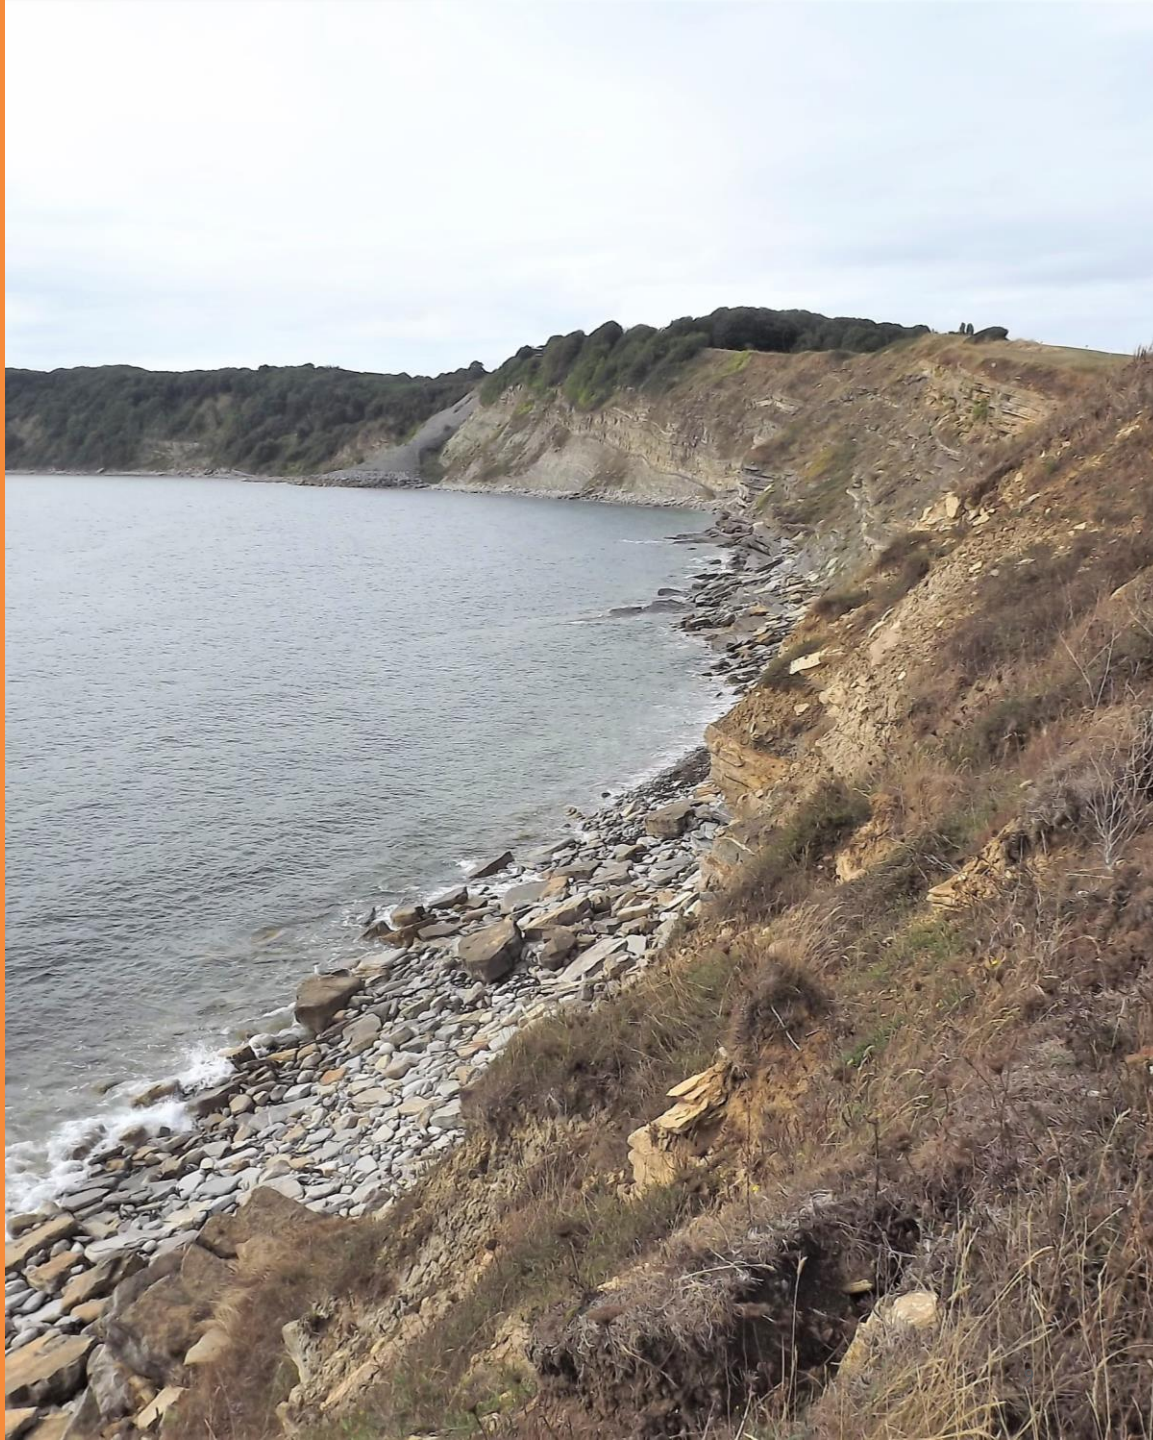
## DIFFERENT PROBLEMS OF EROSION

This section of coast shows different approaches to the problem of erosion.

Durlston Bay, for instance, is being eroded by wave action and mass-movement (or landslides).

In coastal management this is an area of *no active intervention* to a large extent as it is part of the Jurassic Coast World Heritage Site.

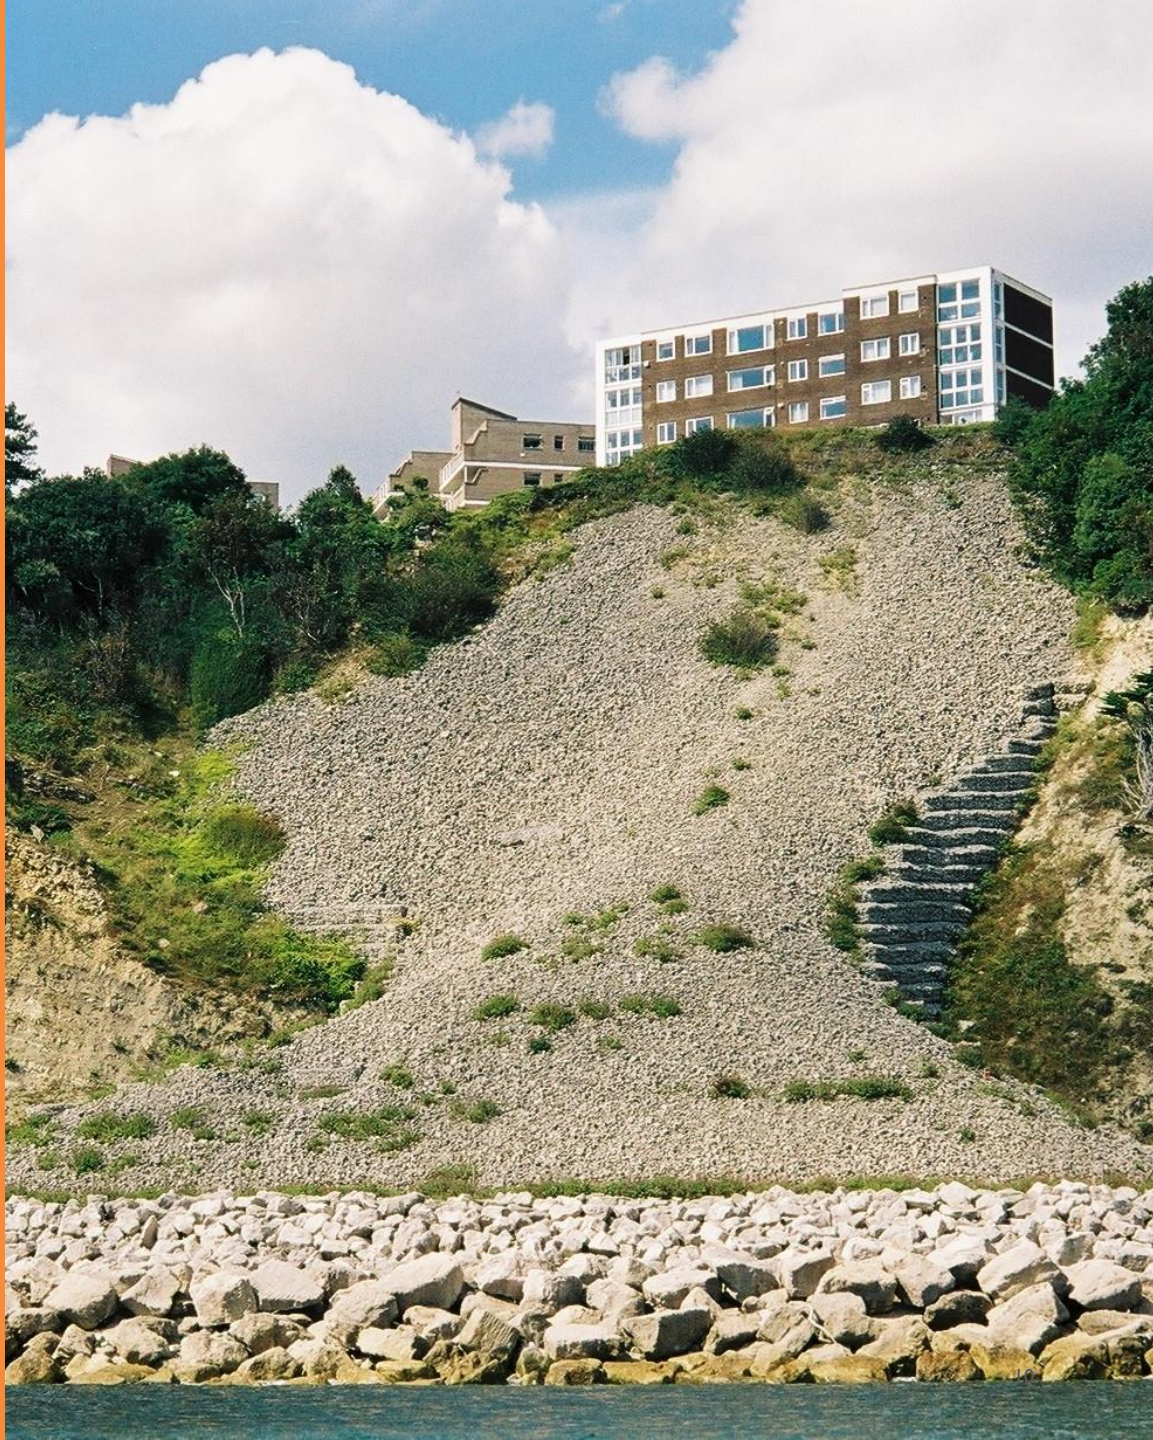
## ONE EXCEPTION!

This is the site of a major landslide in 1984 and hard engineering was put in place in 1989 to protect the apartment block on the cliff top.

However, this is an eyesore and probably wouldn't have got planning permission after the World Heritage status was gained in 2001.

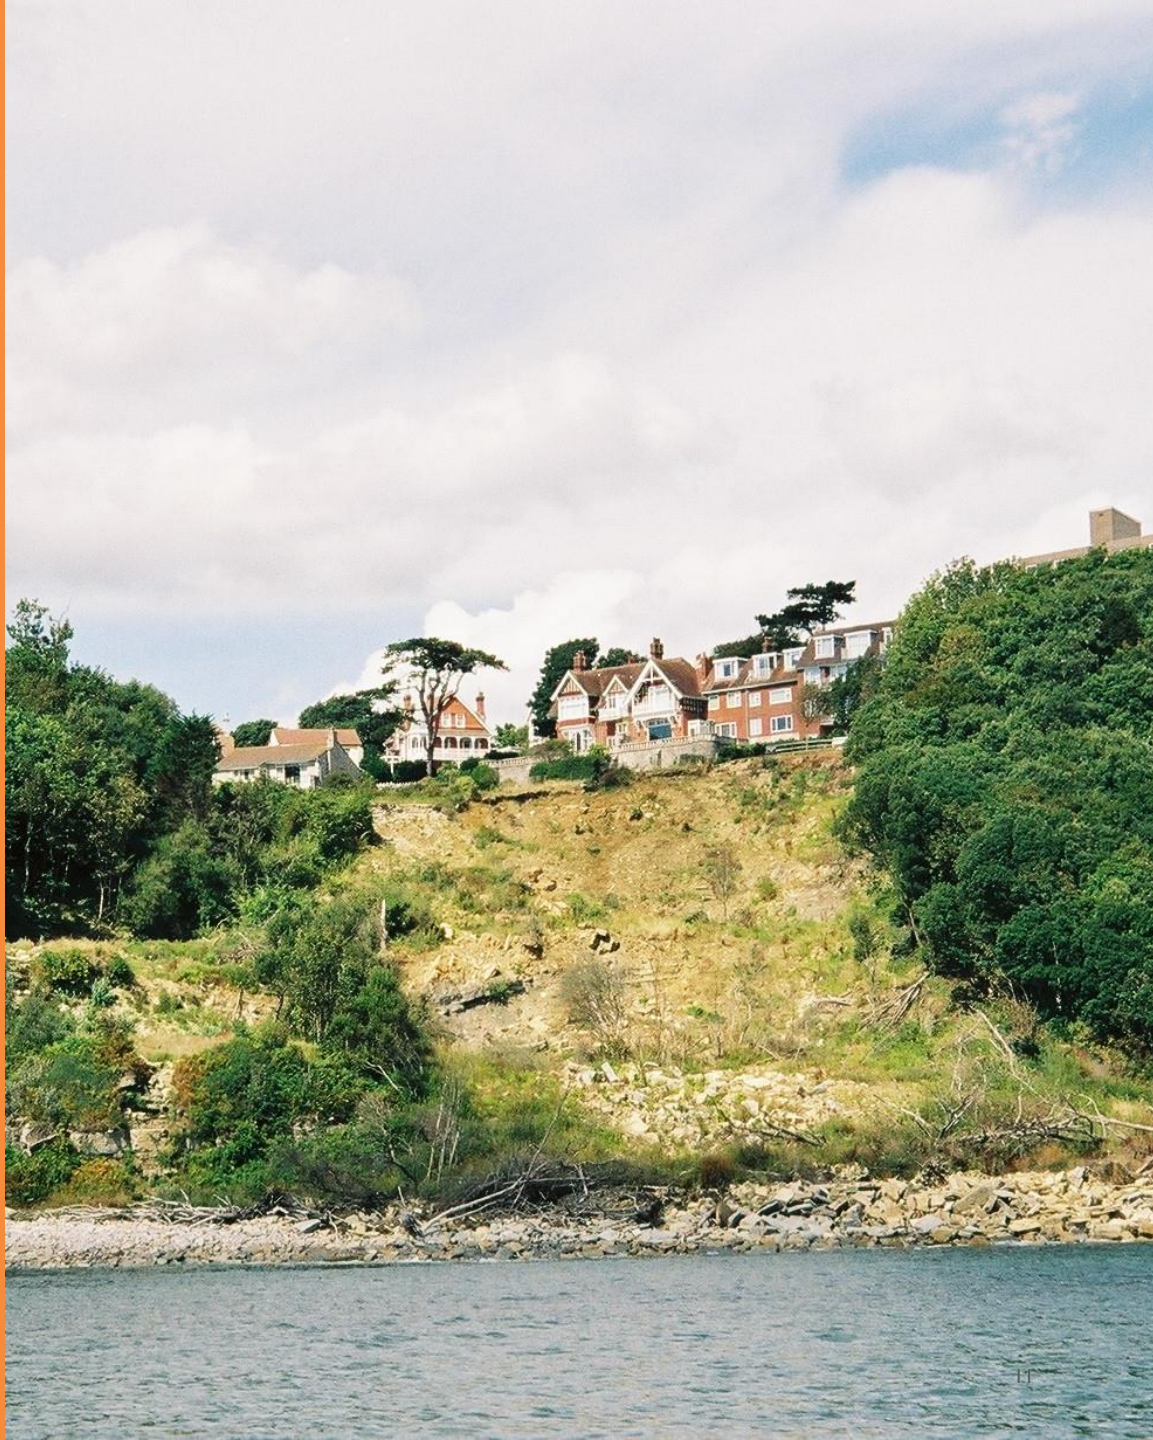
## **ANOTHER EXAMPLE OF EROSION IN DURLSTON BAY**

As a result of a wet winter in 2000-2001 there was a major landslide south of the one seen in the previous slide. Housing was marginally less at risk but gardens were lost.

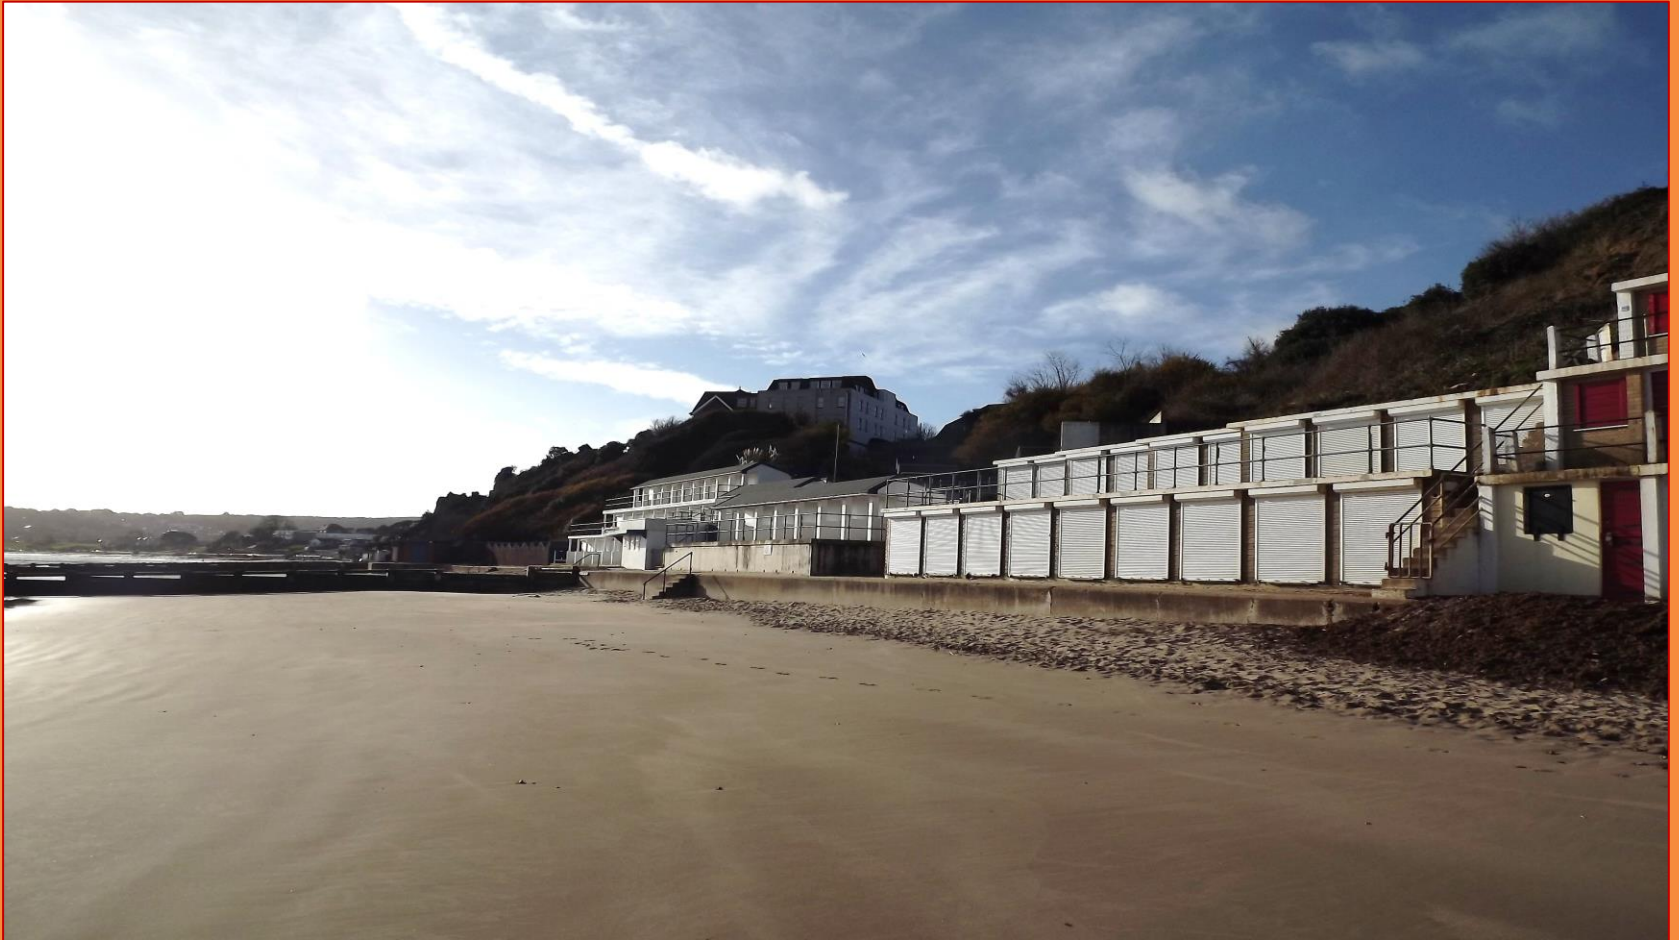
# IN SWANAGE BAY A SEA WALL PROTECTS THE TOWN

This is an example of 'hold the line' in terms of coastal protection, when property has great value.

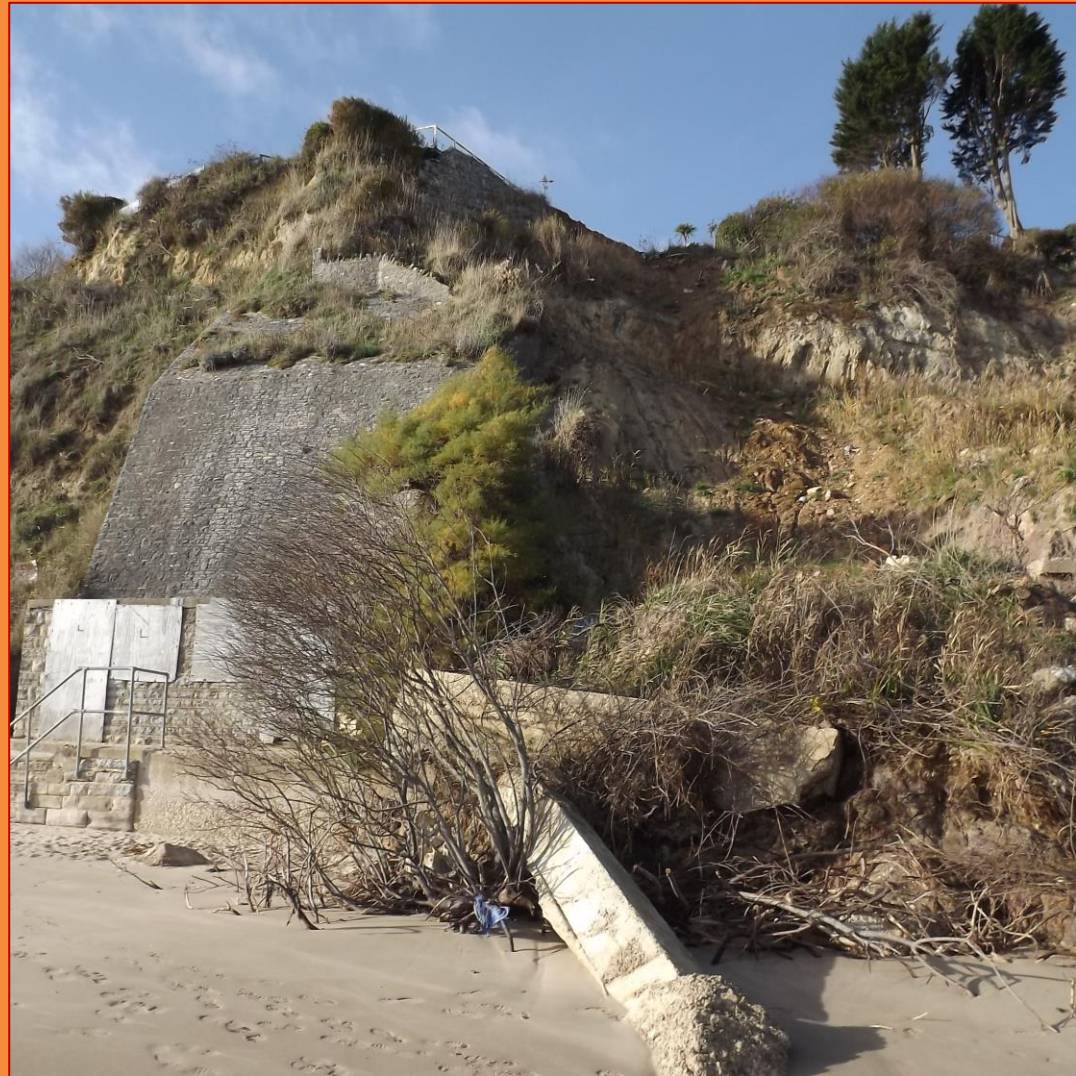
# FURTHER NORTH THERE ARE MORE PROBLEMS

Here the cliff face is higher and the weak Wealden Bed, consisting of sandstone and clay are more liable to be affected by landslides.

You can see remains of earlier attempts to protect the cliffs.

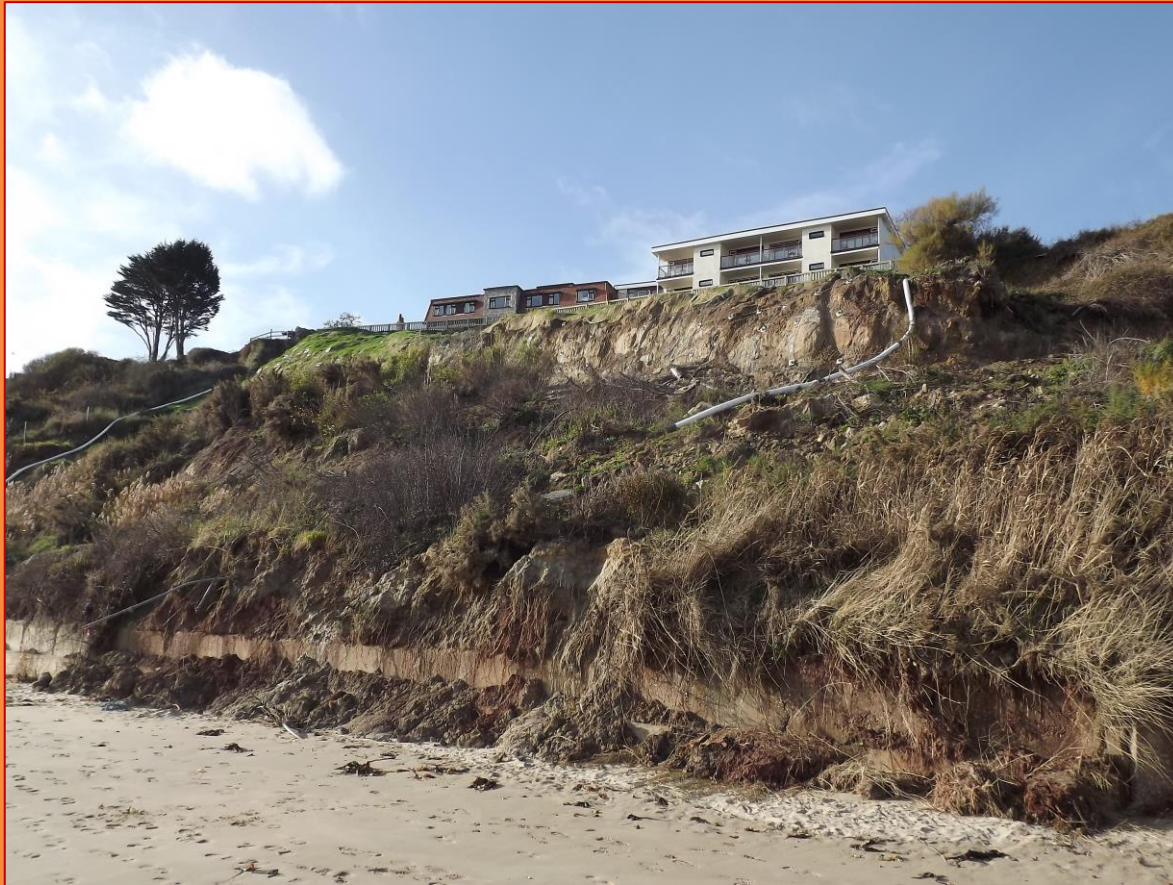
# THE PINES HOTEL LANDSLIDE

This picture was taken in December 2013 following a major landslide below the Pines Hotel.

**Why are there pipes?**

The pipes are there to drain the ground because water makes landslides more likely.

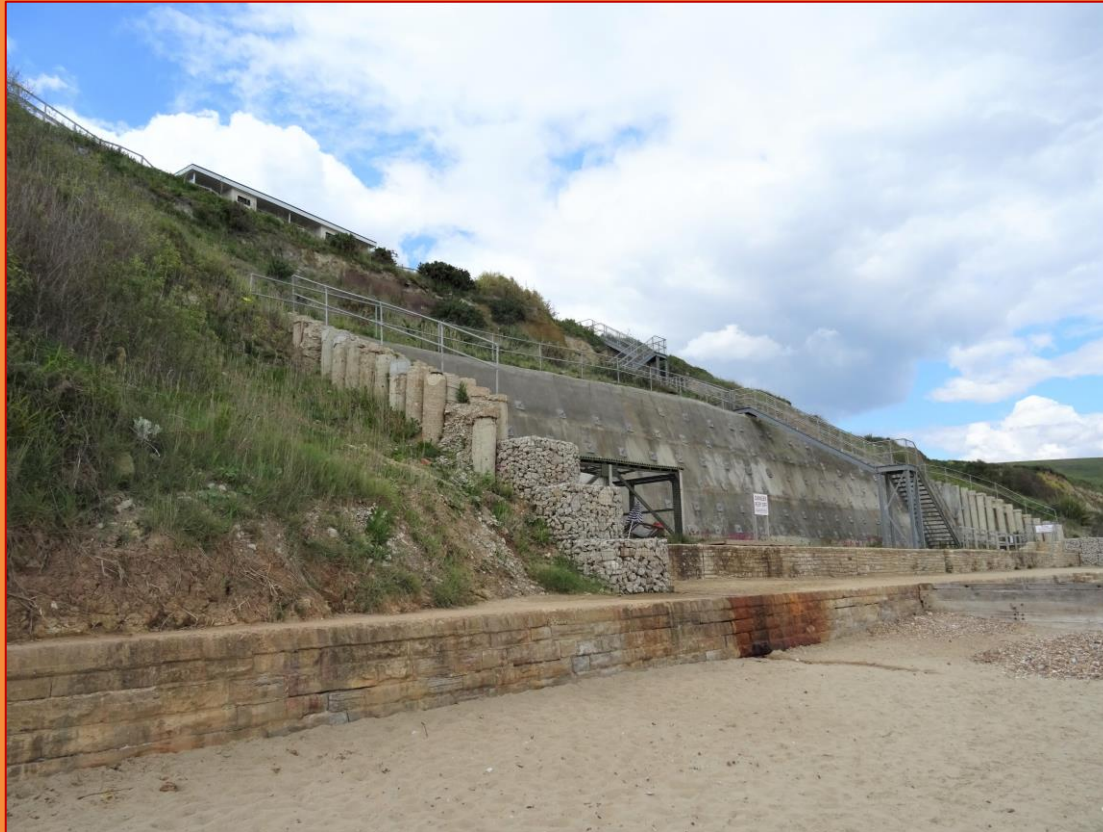
# OVER A MILLION POUNDS HAS BEEN SPENT PROTECTING THE PINES HOTEL

This involved drainage, building a supporting wall, rock bolts and soil nails to hold the cliff together.

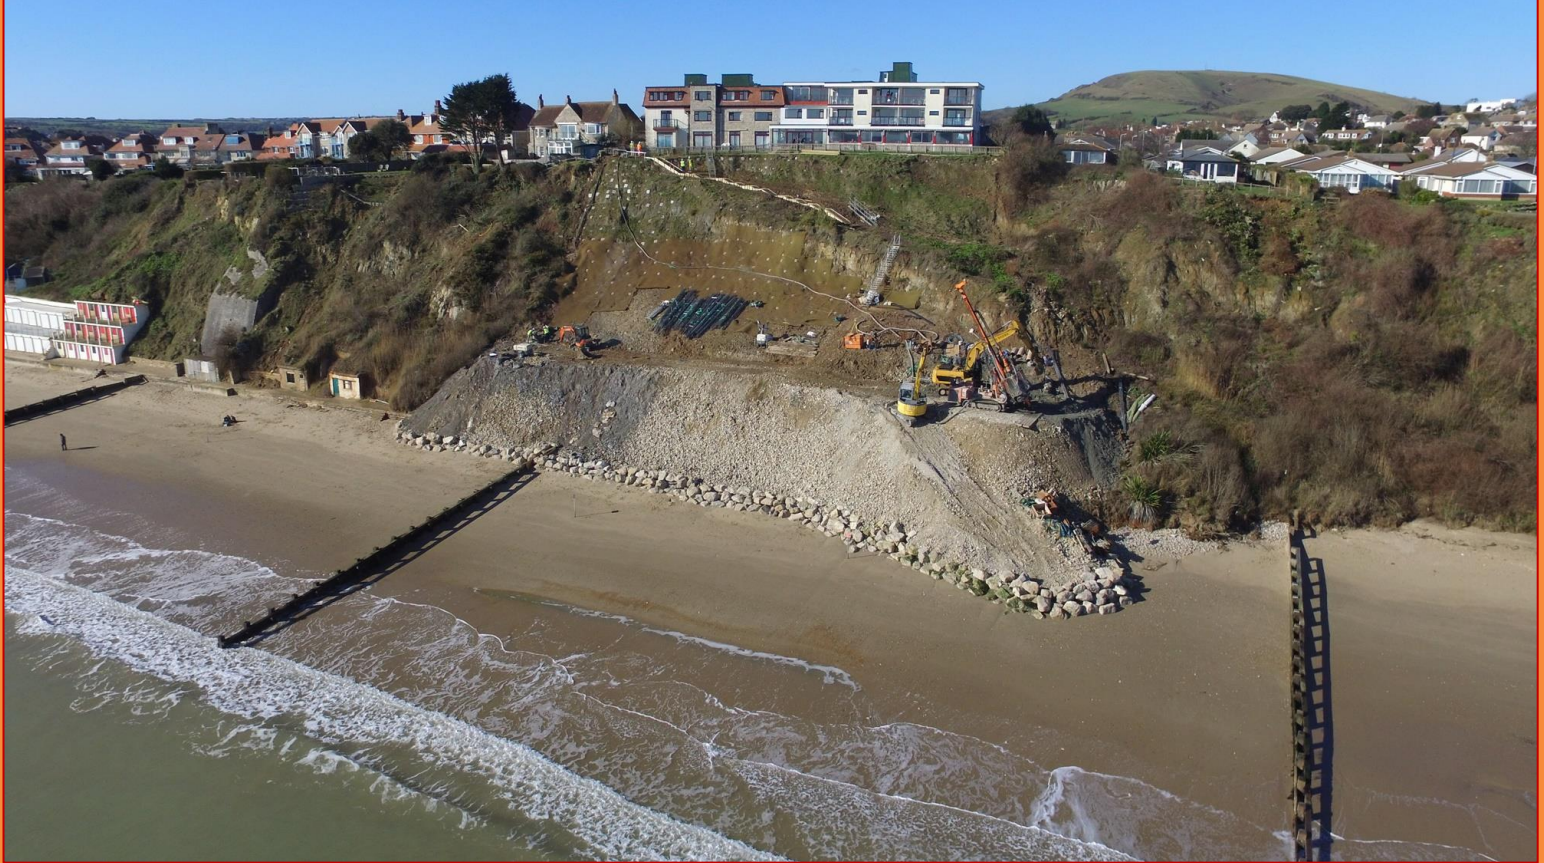
This picture was taken during the construction work to protect the hotel in February 2016.

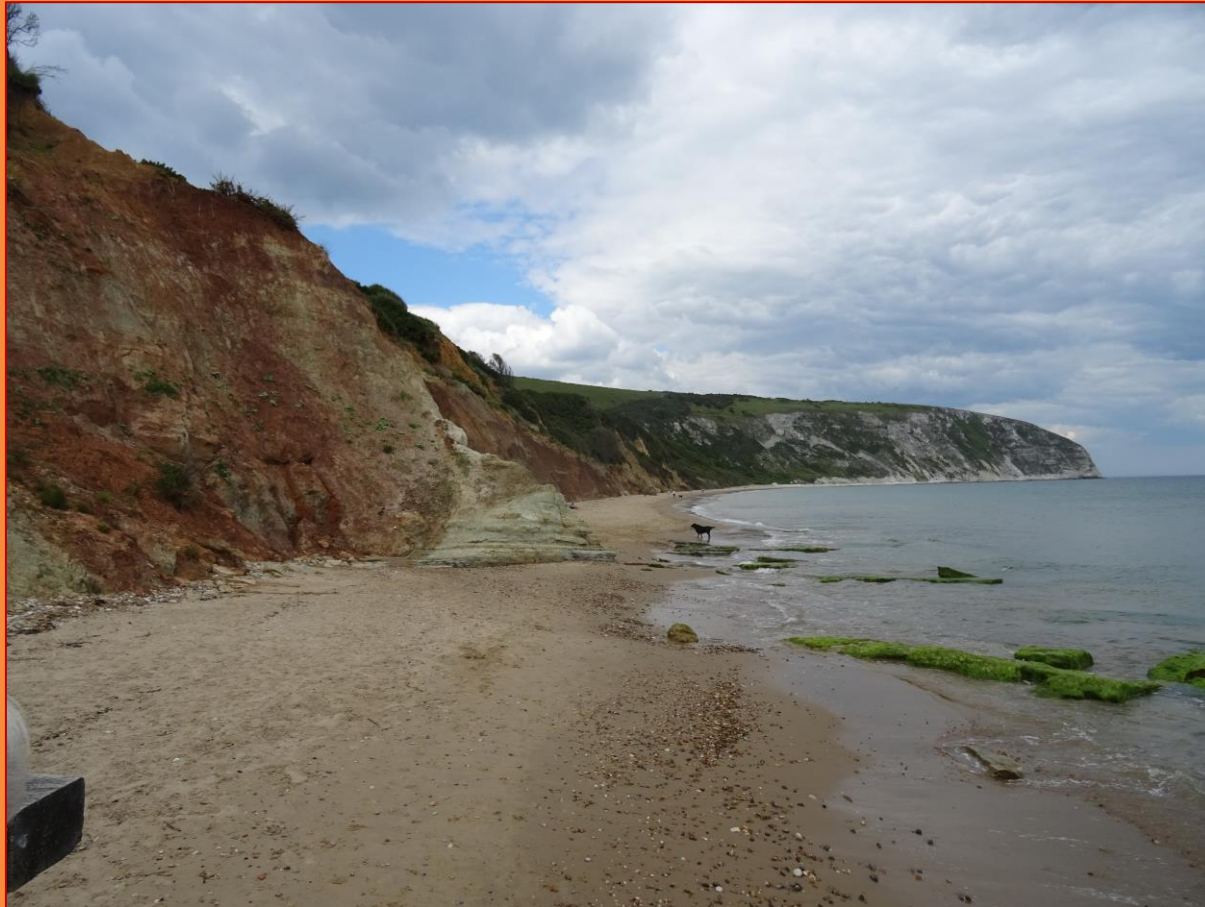
# FURTHER NORTH IN SWANAGE BAY...

No property is at risk so there is little coastal protection

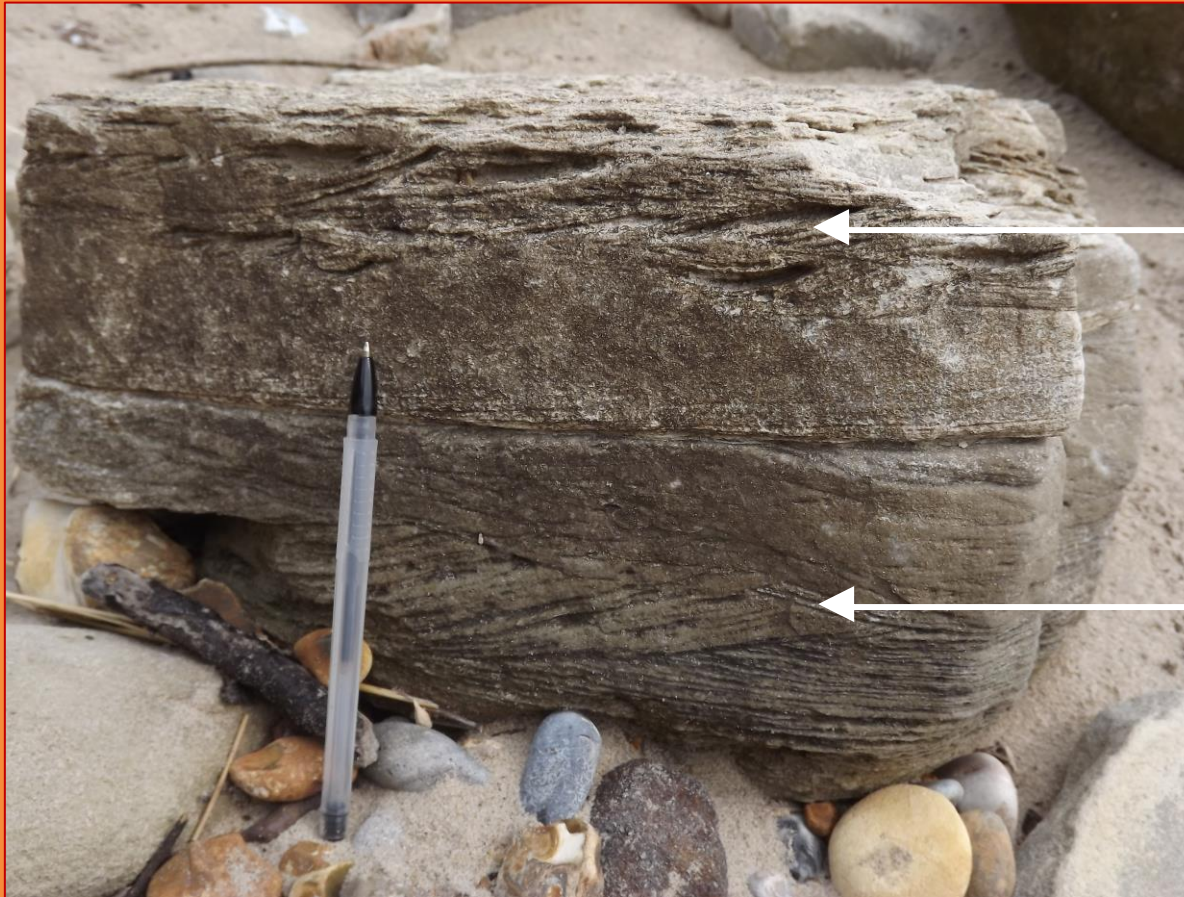
# GEOLOGY IS STILL VISIBLE

Evidence of cross-bedding with ripple structures formed on the river bed.

Cross-bedding, due to changes in direction of flow and partial erosion of earlier set by later event.

The Wealden Beds and the Greensand are well exposed further north in Swanage Bay and there is much of interest with careful observation for geologists to explore.
